# In-field Observations of Damage and Building Resilience: With Examples

James LaDue

01 October 2025

*SCIPP Hazard Resilient Buildings Workshop*

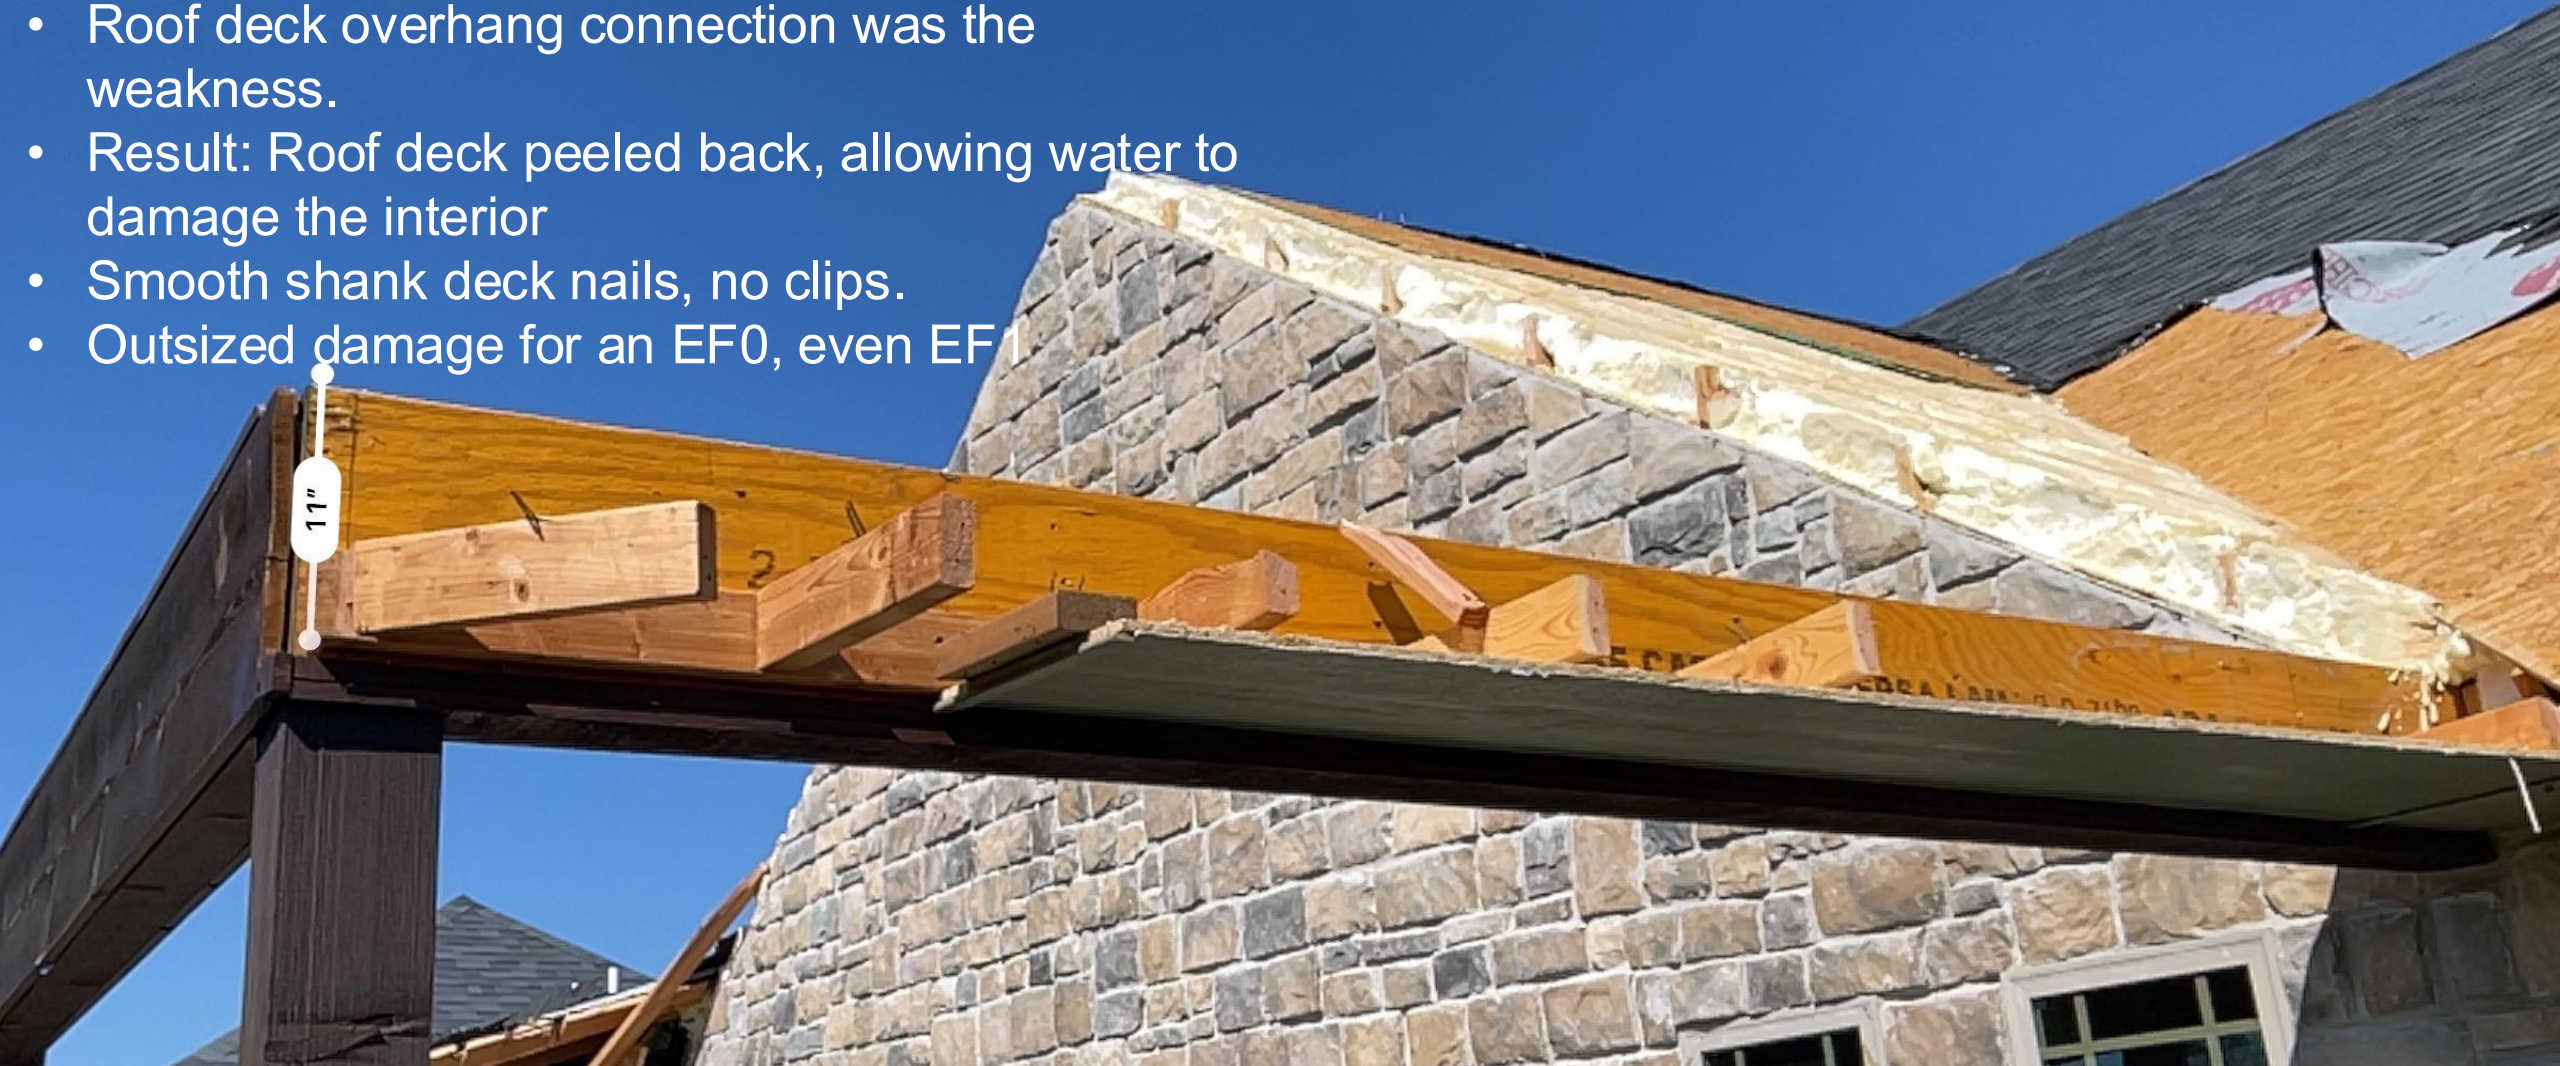
- EF0 determined by the performance of the roof, degree of damage = 2, 80 mph wind
- Roof deck overhang connection was the weakness.
- Result: Roof deck peeled back, allowing water to damage the interior
- Smooth shank deck nails, no clips.
- Outsized damage for an EF0, even EF1

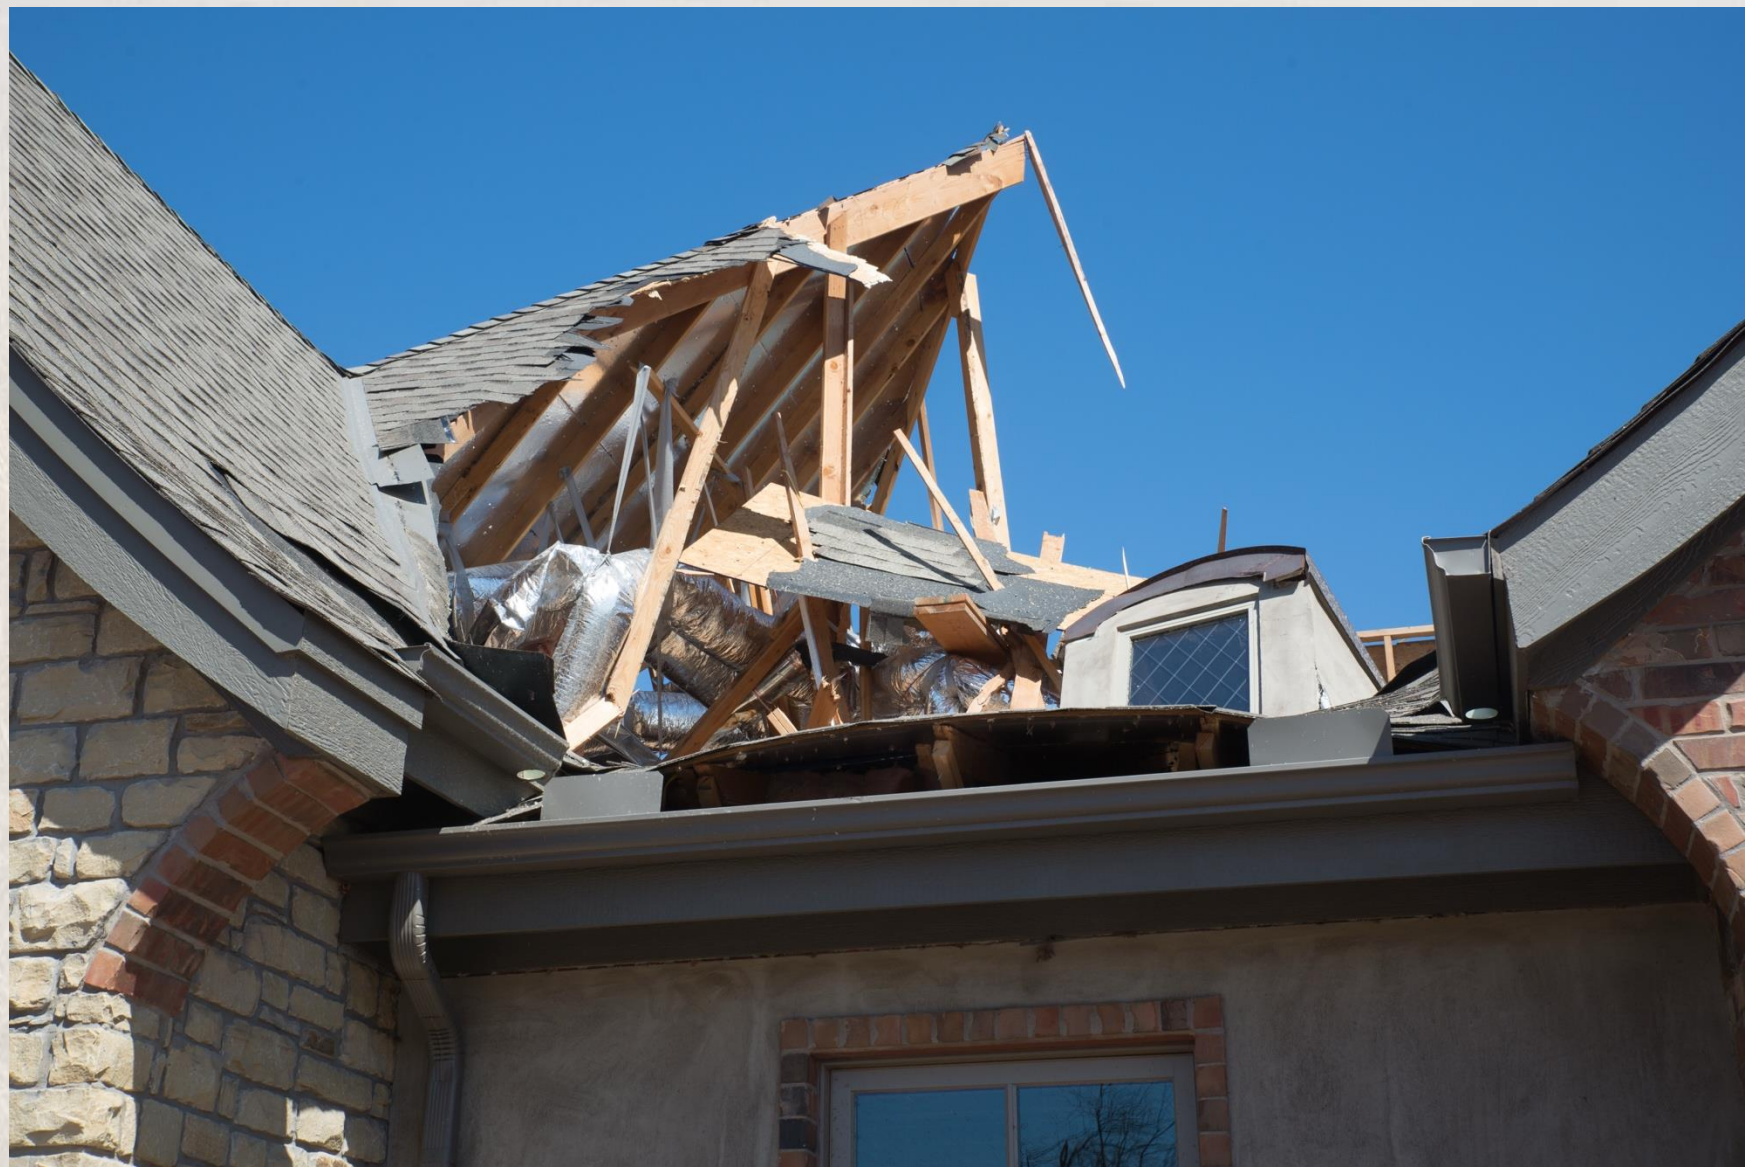
- Degree of Damage 4: Uplift of roof deck > 20%
- Home followed Moore's new 130 mph code, except for...
- The stapled roof deck
- Guess where the damage occurred?
- 110 mph EF1 assigned in 2015
- Lower winds are likely

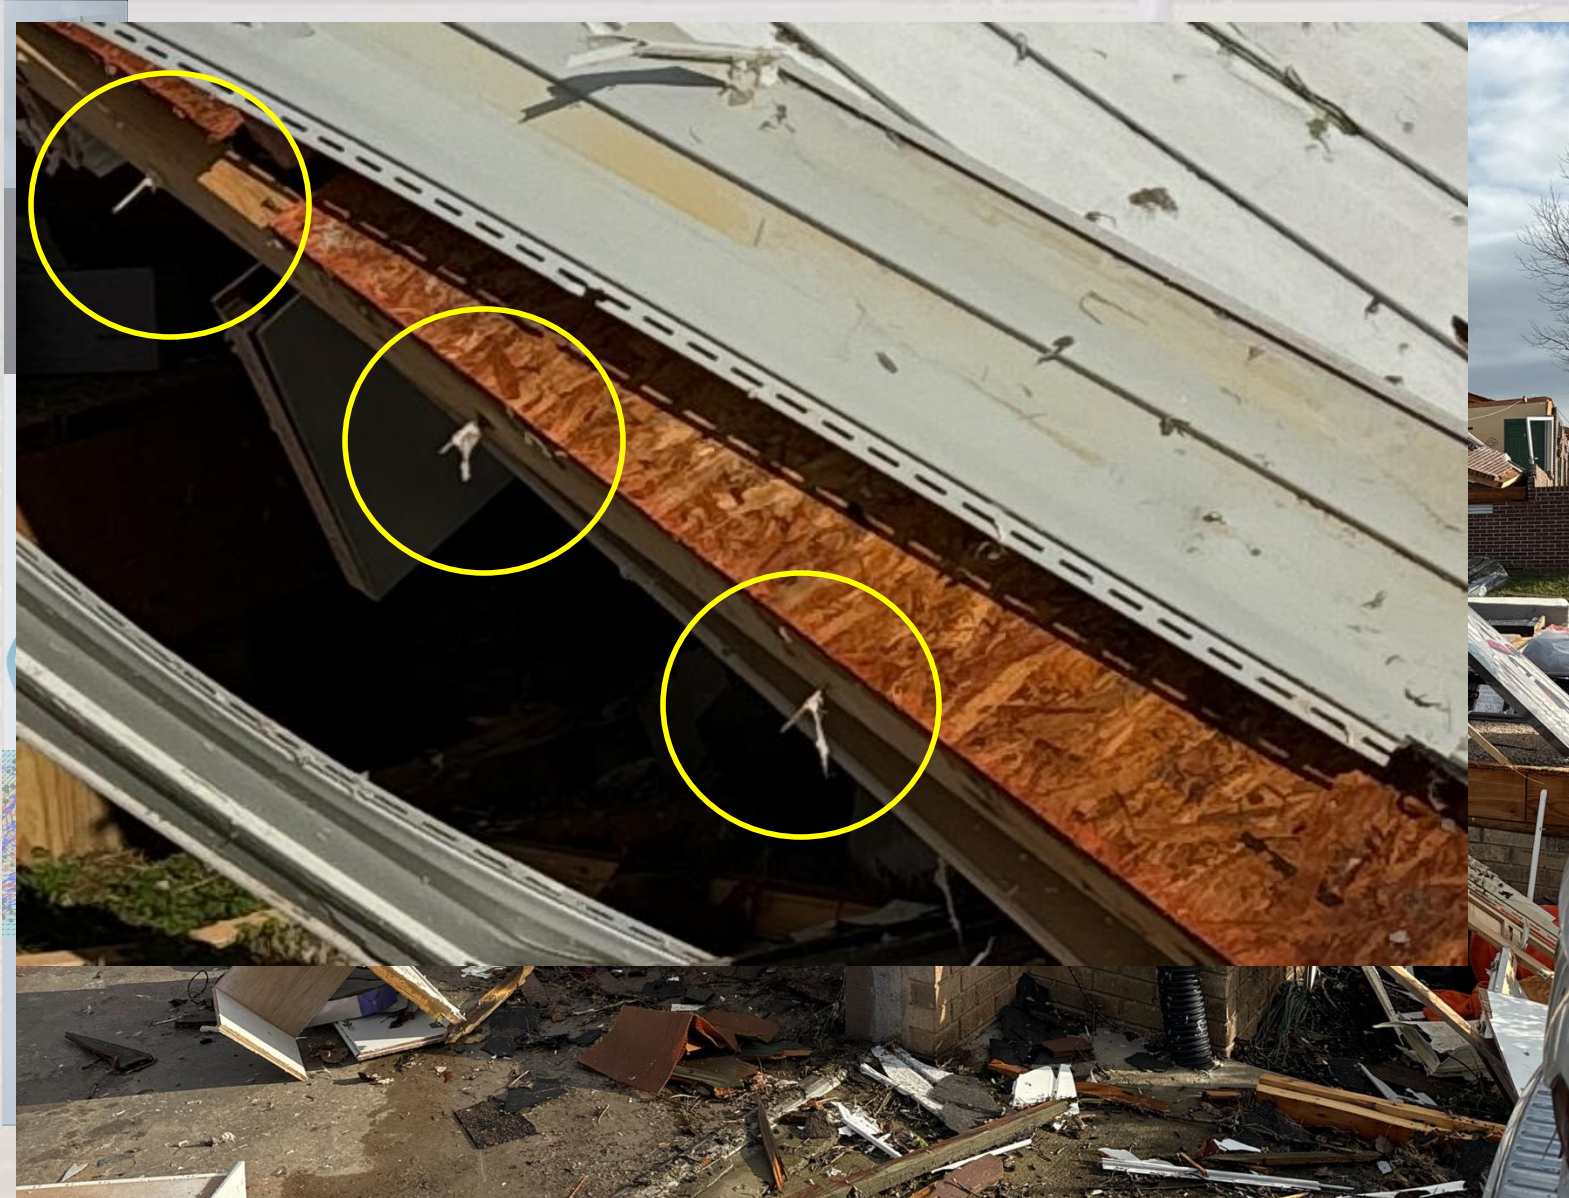
DoD: Entire house shifts off foundation

EF Rating: EF2 Damage Direction: N/A

This house did not exhibit a rigid slide. It disassembled. Still, go with LB EF3. Would've been EF4 had there been bolts or overlapping rigid sheathing with floor.

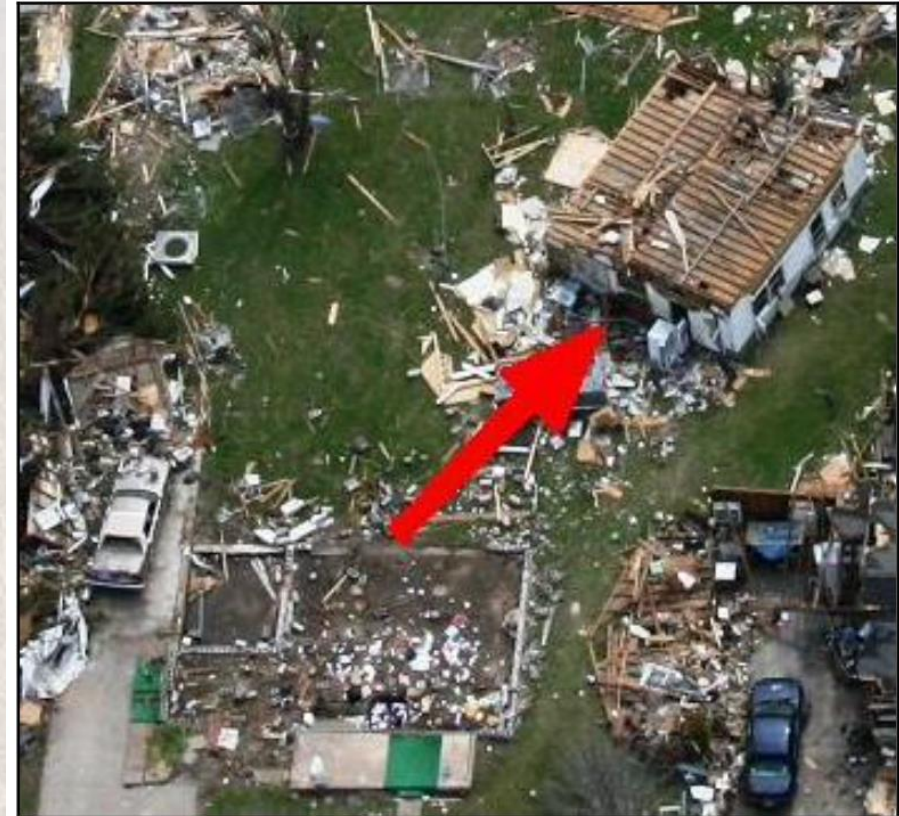
This Slider is classic. The weak spot was the floor diaphragm with the foundation.

House then slid as a body, but lost its roof.

House was rated with the roof or as a slider

Result = EF2.

**Figure 4.** Example showing a home that was “swept clean” from its foundation that was rated EF-2 based the removal of its roof. Note vehicle remained within the destroyed garage.

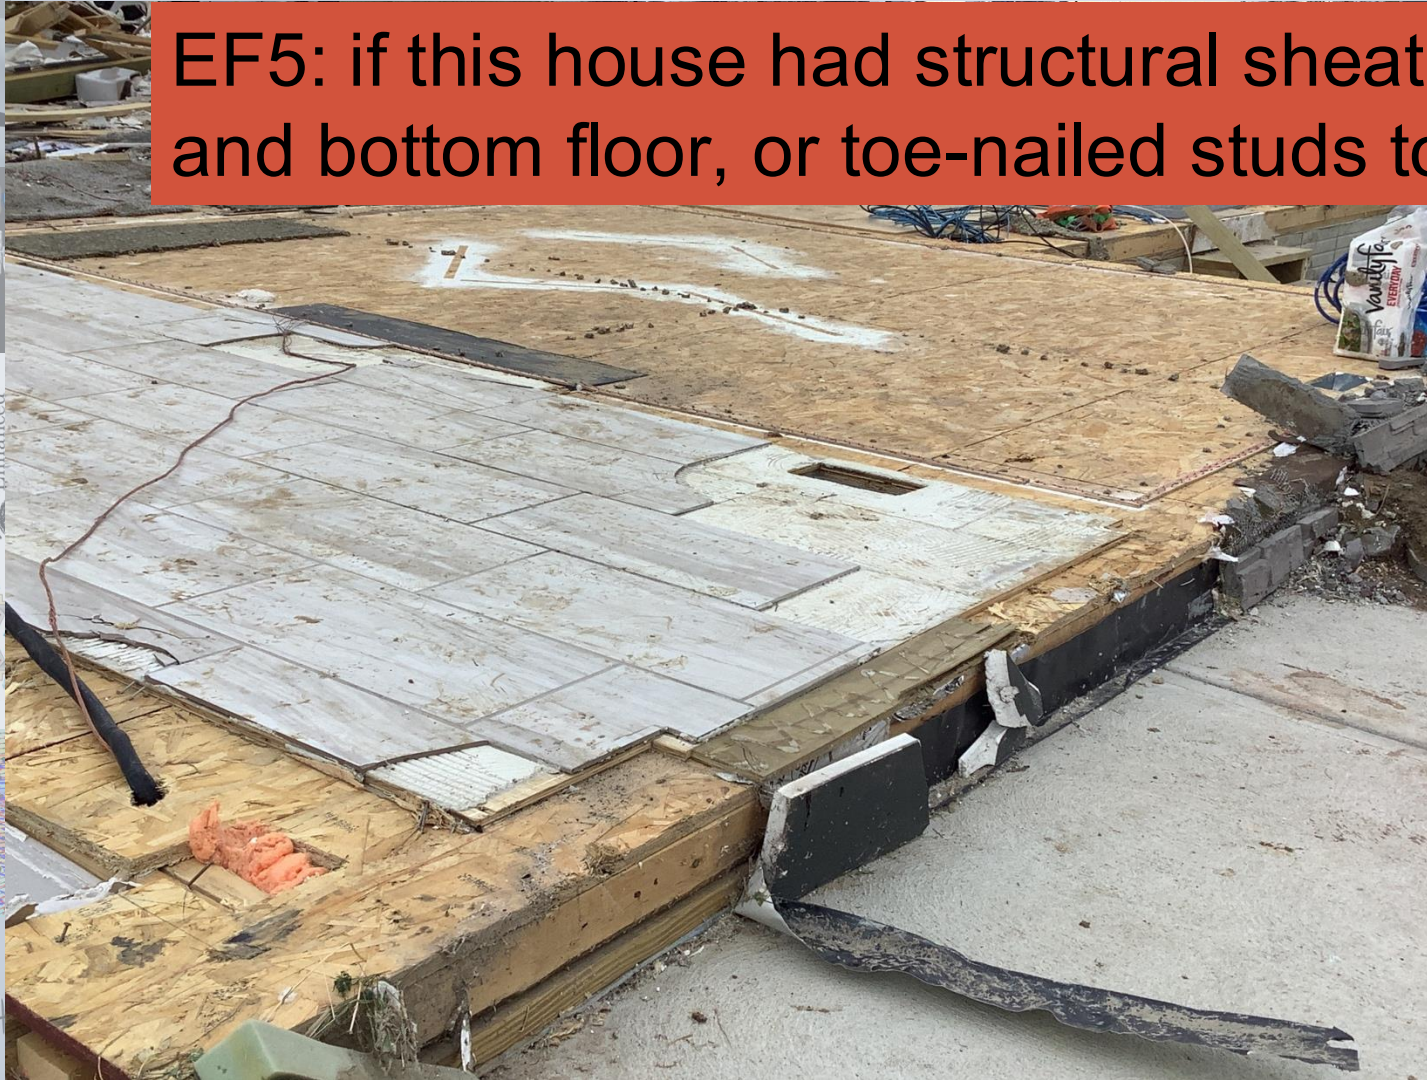
EF5: if this house had structural sheathing overlapping wall and bottom floor, or toe-nailed studs to floor.

DoD: All walls collapsed

EF Rating: EF4 Damage Direction: N/A

Comments: All walls collapsed. Foundation was swept clean of nearly all debris. Home built and inspected within past 2 years. Primary connector from floor to walls were nails. Sill plate bolted to poured foundation.

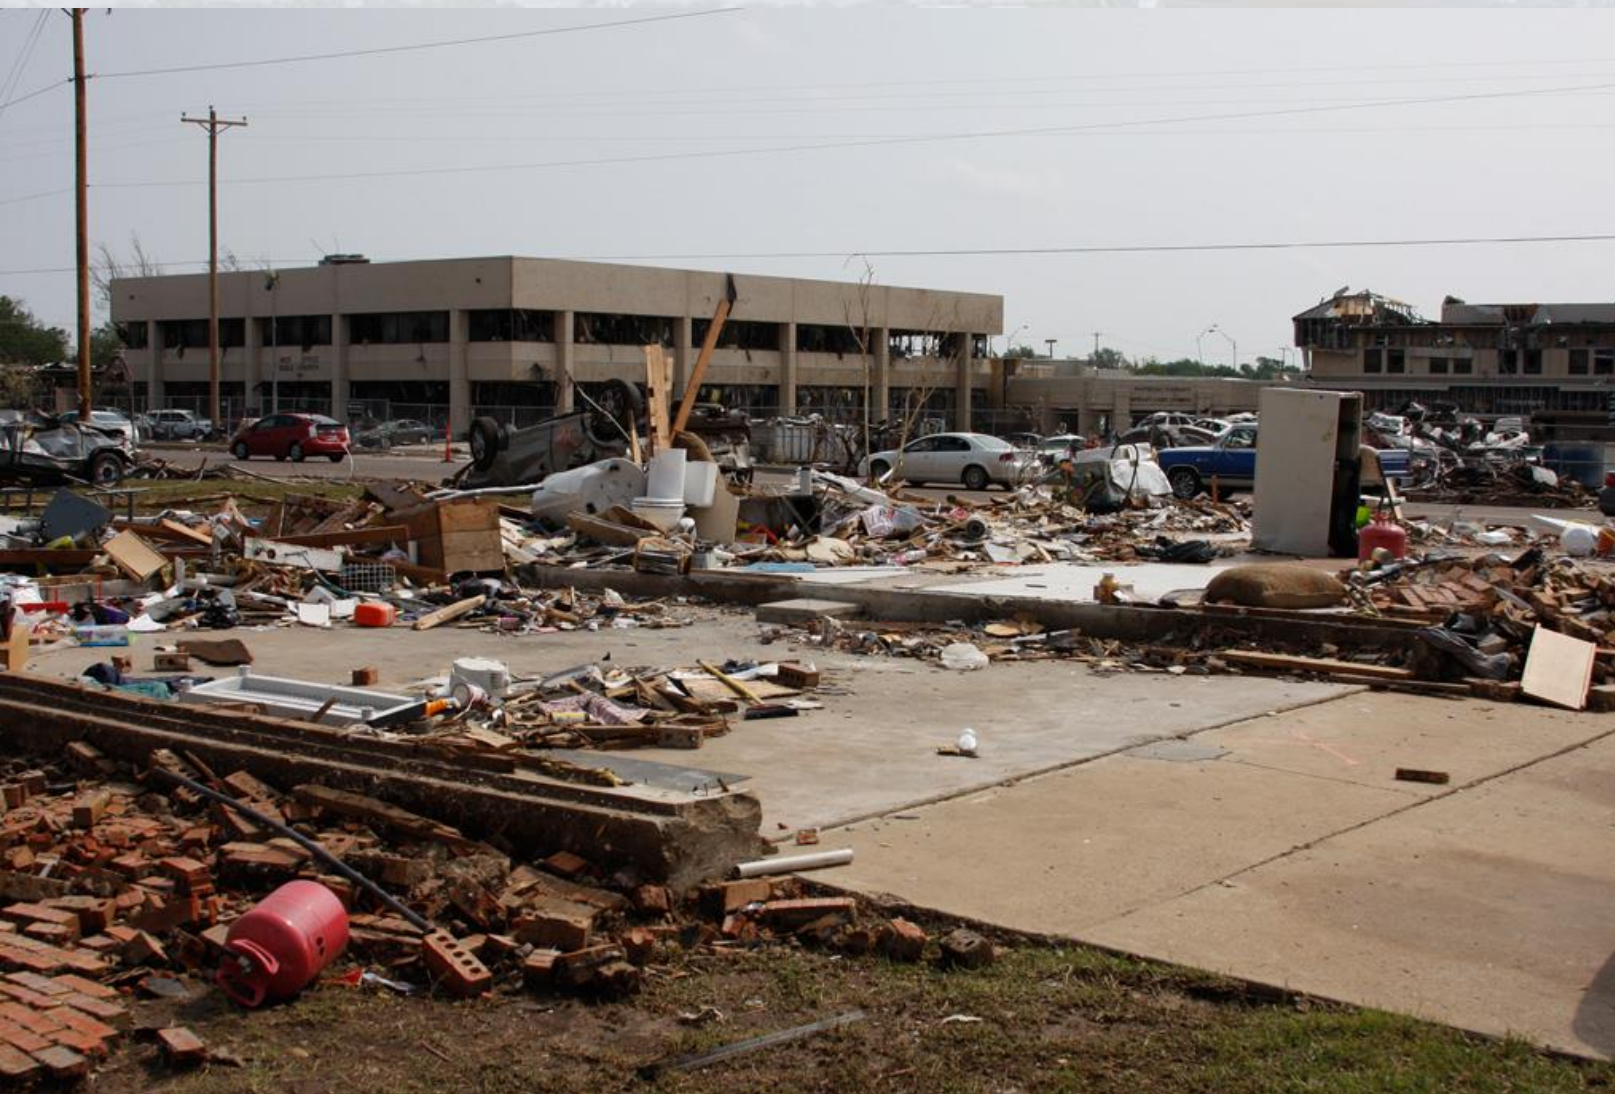
Anchor bolts, toe-nailed studs to bottom plates. Likely corner sheathing only.

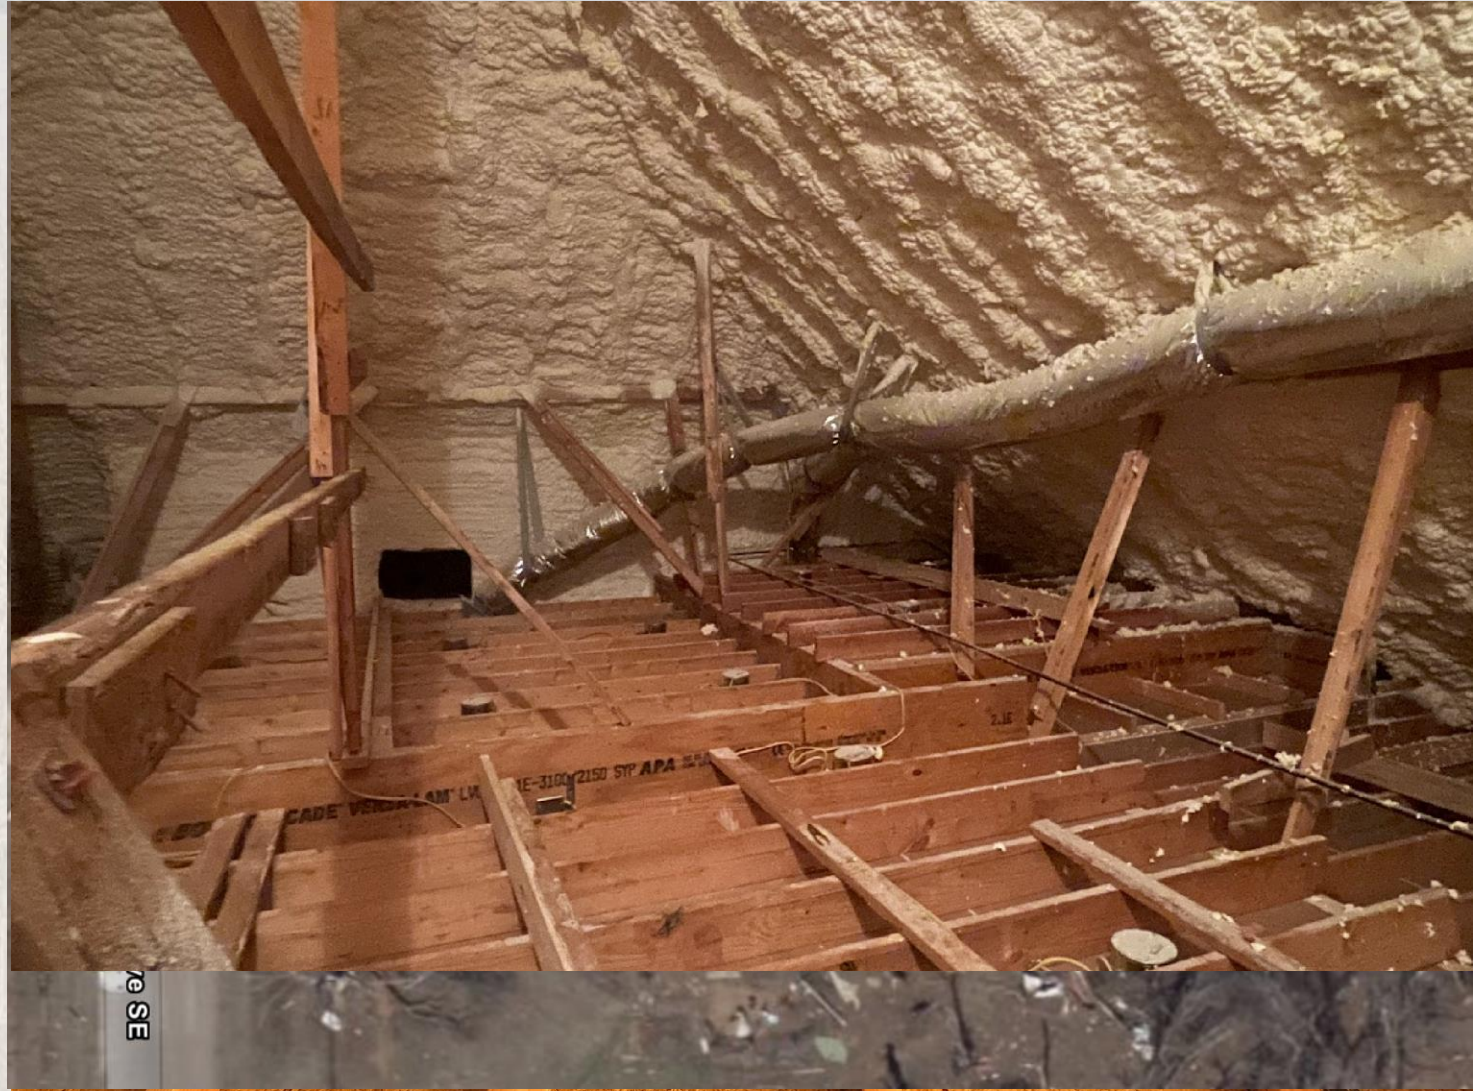
EF2 damage to trees yet  
minimal shingle damage

Rafter clips, reinforced  
decking inc. adhesive  
insulation

DoD=3, windows broken

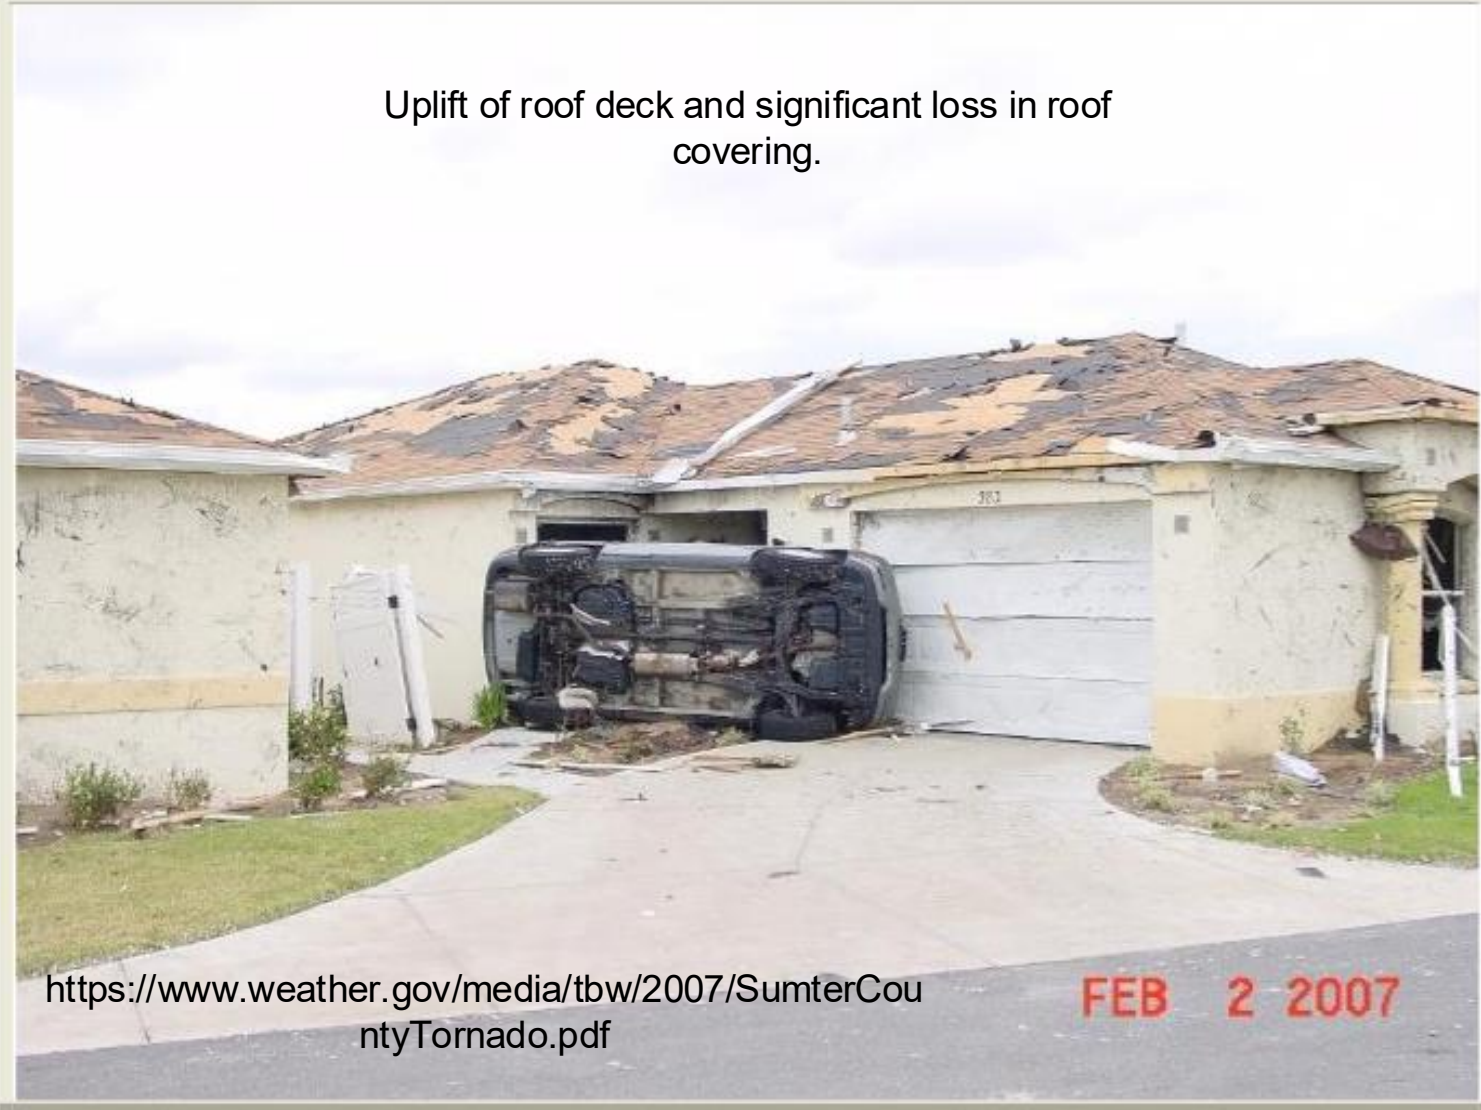
- Vehicle blown into doorway
- Built in 2006
- Post-Andrew building code
  - <https://stantec.maps.arcgis.com/apps/MapSeries/index.html?appid=a053ac48343c4217ab4184bc8759c350>
- DoD 4: Max wind speed estimate not enough with current EF scale. But EF2 estimate is a sufficient start.

Uplift of roof deck and significant loss in roof covering.

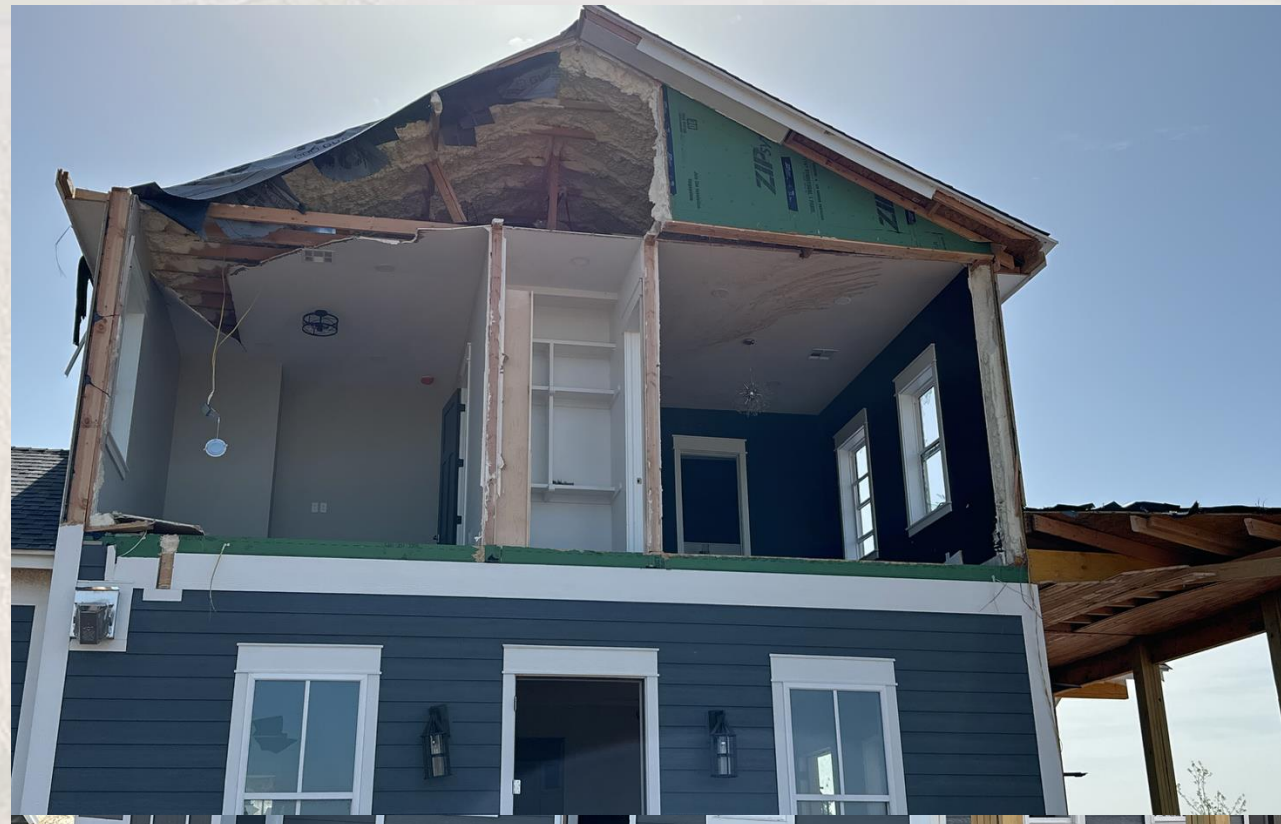
Unbraced gable ends are weaknesses

Walls popped out due to weak connections and internal pressure increase due to broken windows.

Temptation would be to go with DoD7 **"exterior walls collapsed"**.

However, shingle loss is minimal. Caution may say go with DoD 6 **"Large sections of roof structure removed, most walls remain standing"**.

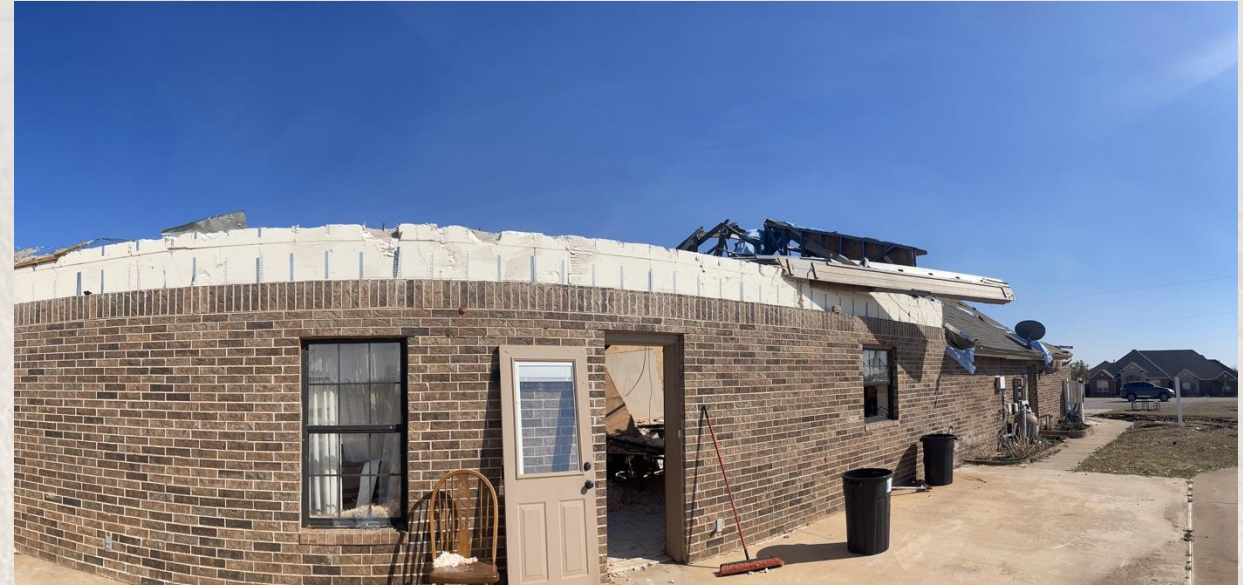
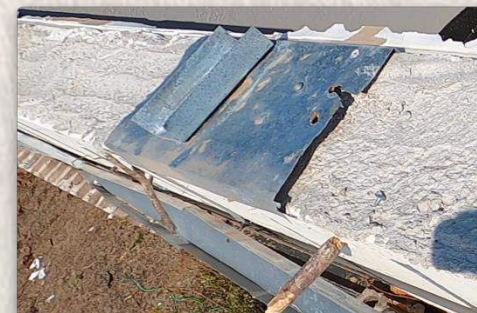
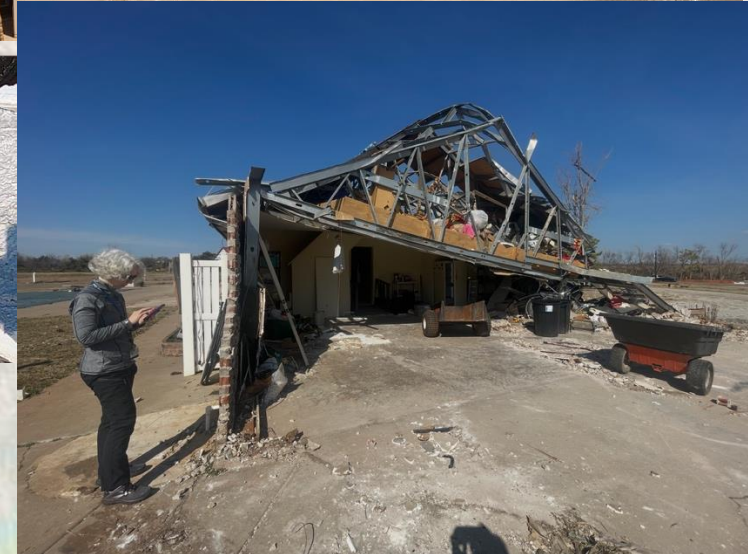
Steel reinforced concrete walls.

Cold formed steel roof rafters.

Weak roof-to-wall connection.

This is a DoD 6 with a lower-than-expected wind assigned ~115 mph EF2.

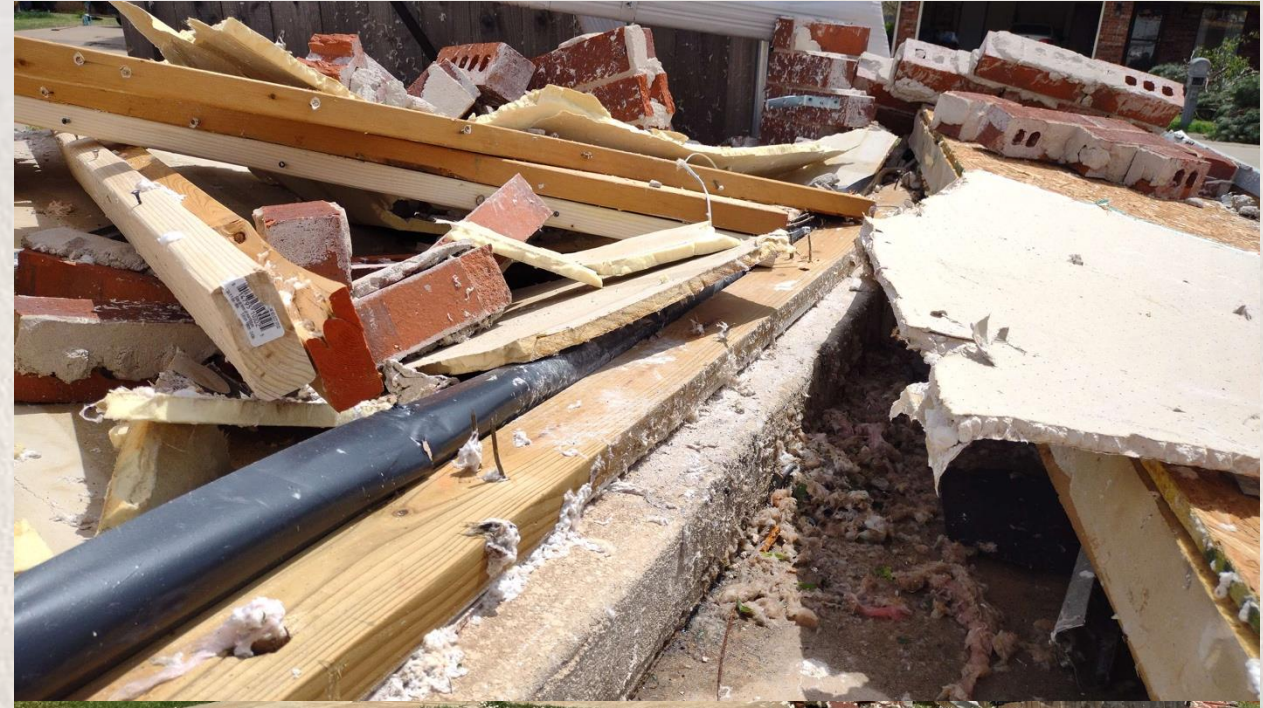
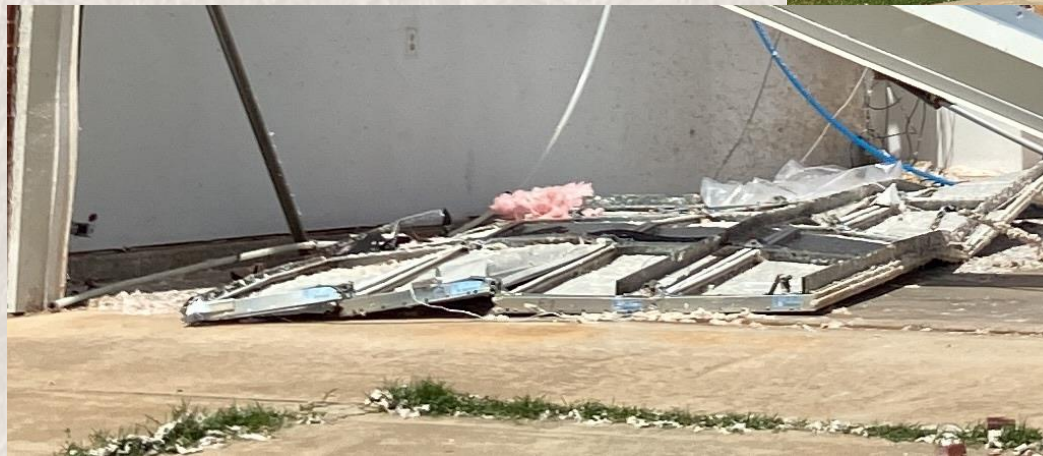
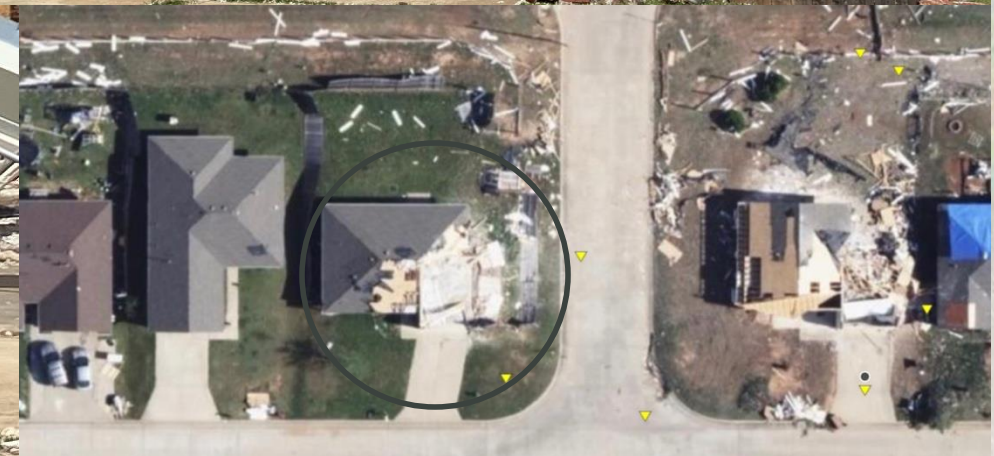
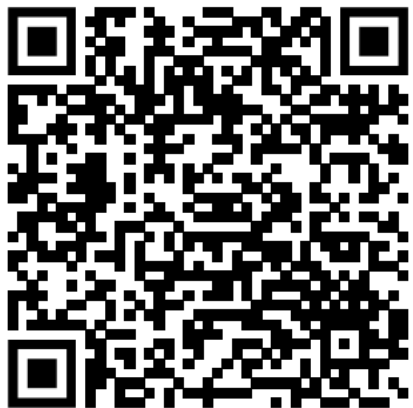
Assigned DoD 7 "Exterior Walls Collapsed"  
132 mph.

Garage door blew in and overpressure  
removed adjoining walls and roof.

Rest of the roof has little shingle damage.

Suggest DoD 6, 120 mph or DoD 7 same  
wind speed.

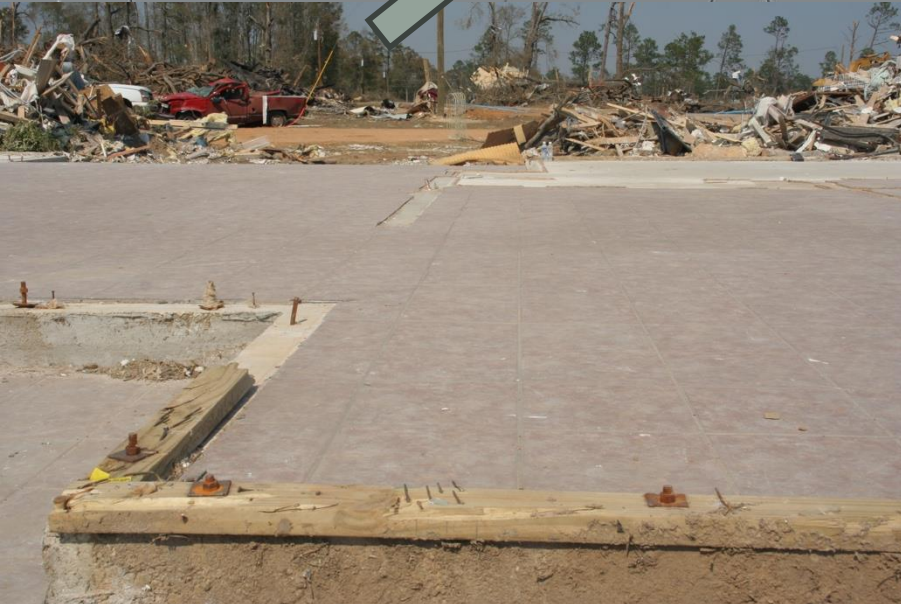
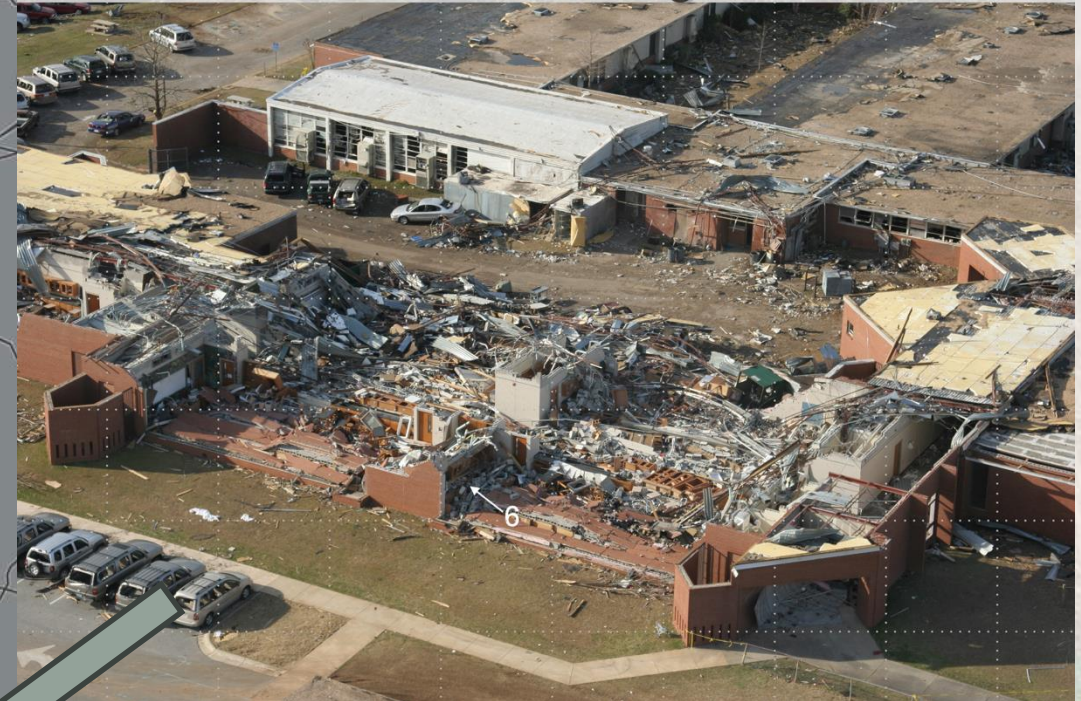
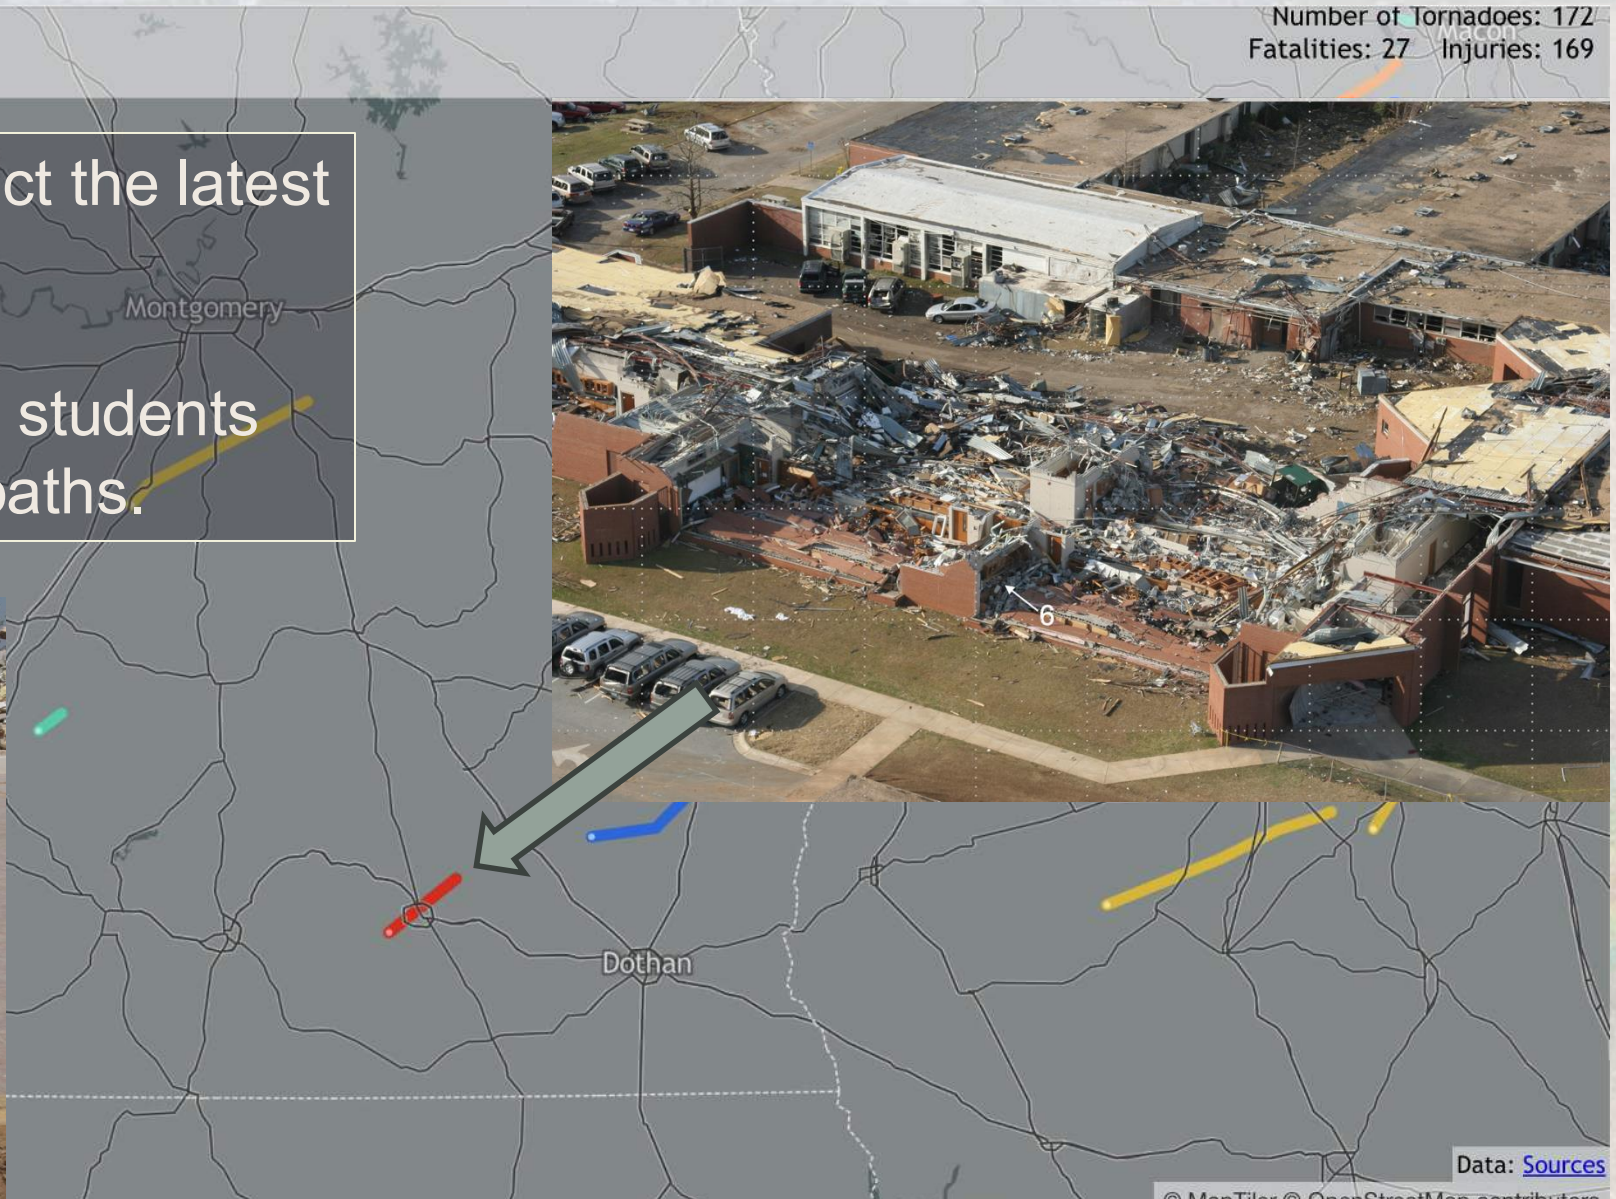
The enterprise school failed the students due to lack of continuous load paths.
