# In-field Observations of Damage and Building Resilience: With Examples

James LaDue

01 October 2025

*SCIPP Hazard Resilient Buildings Workshop*

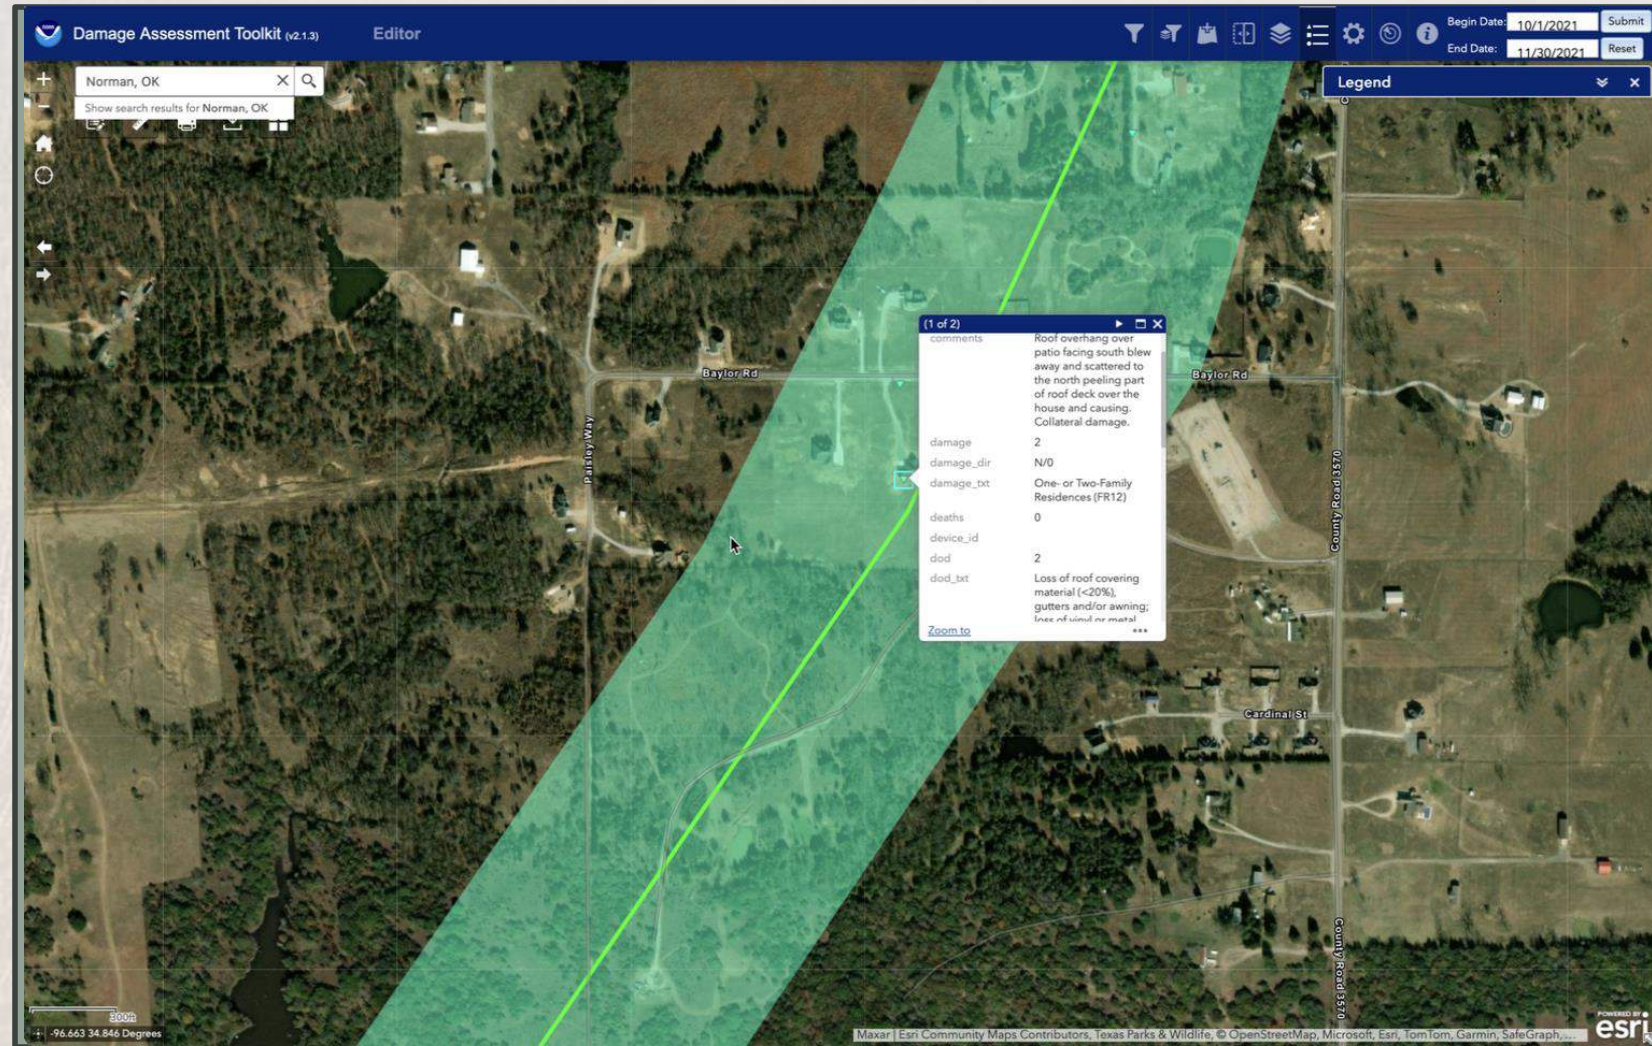
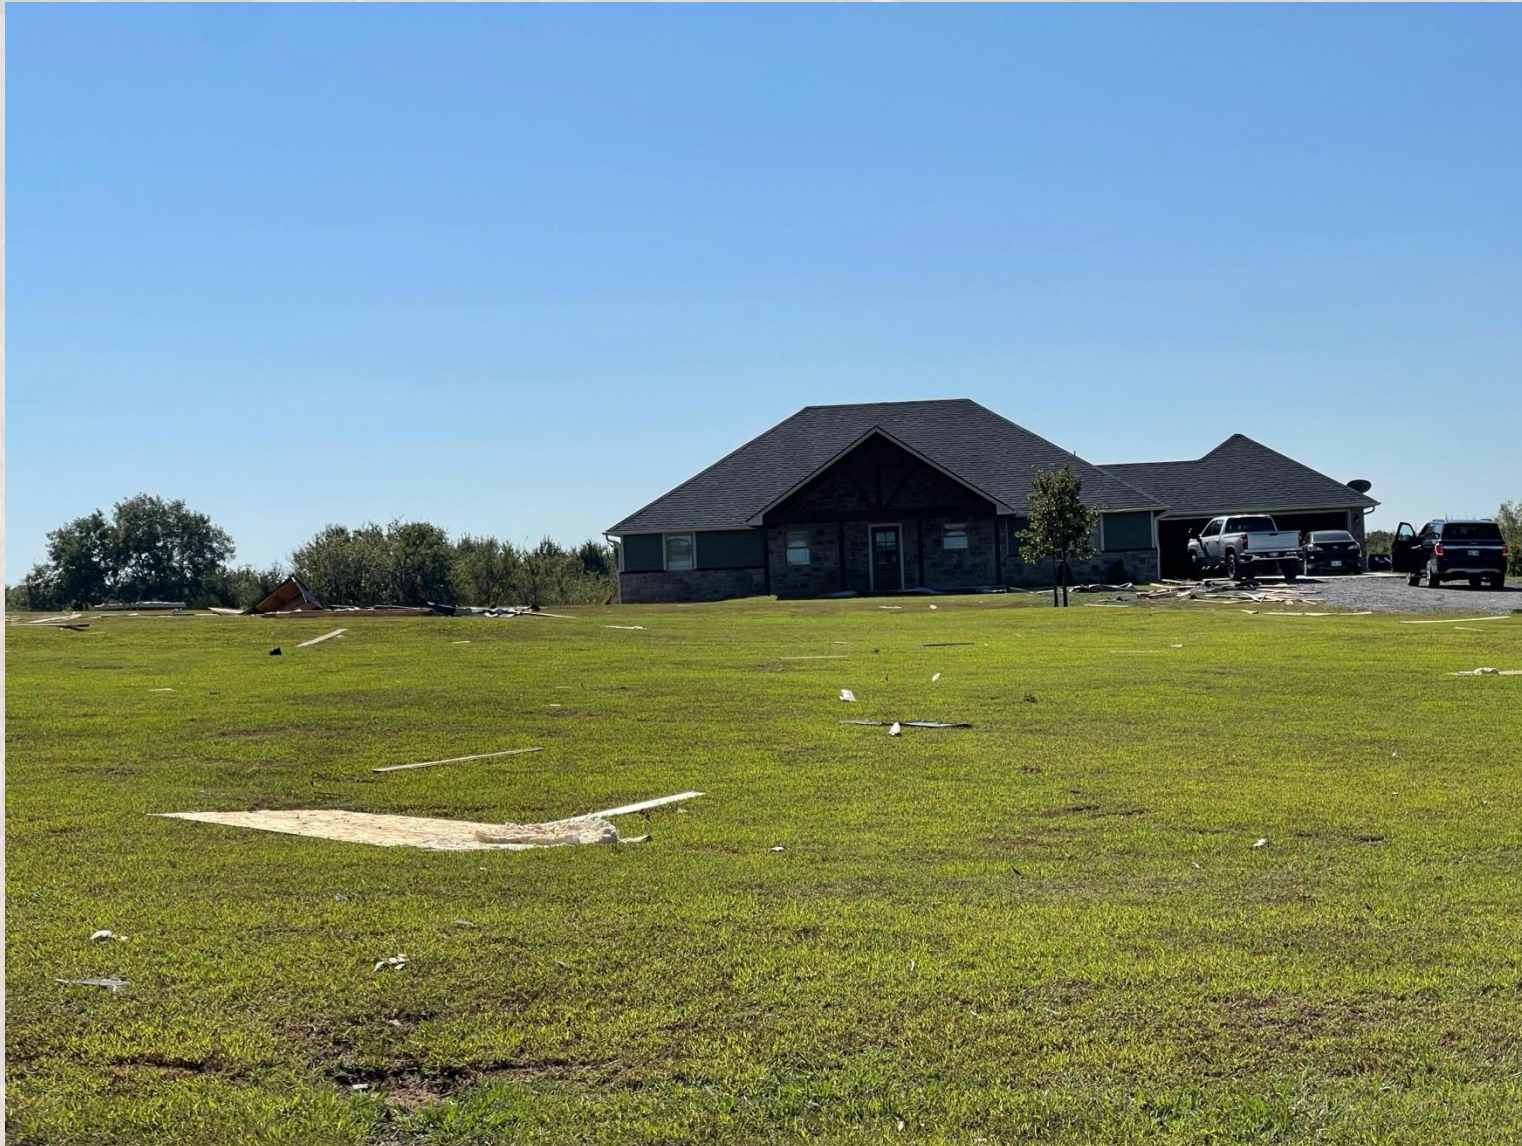
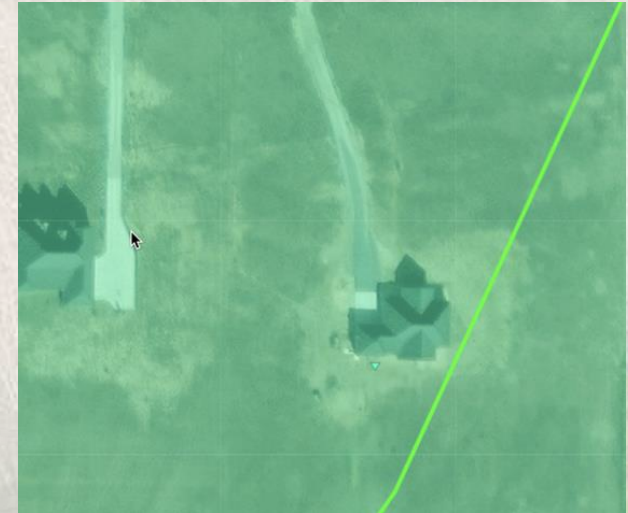
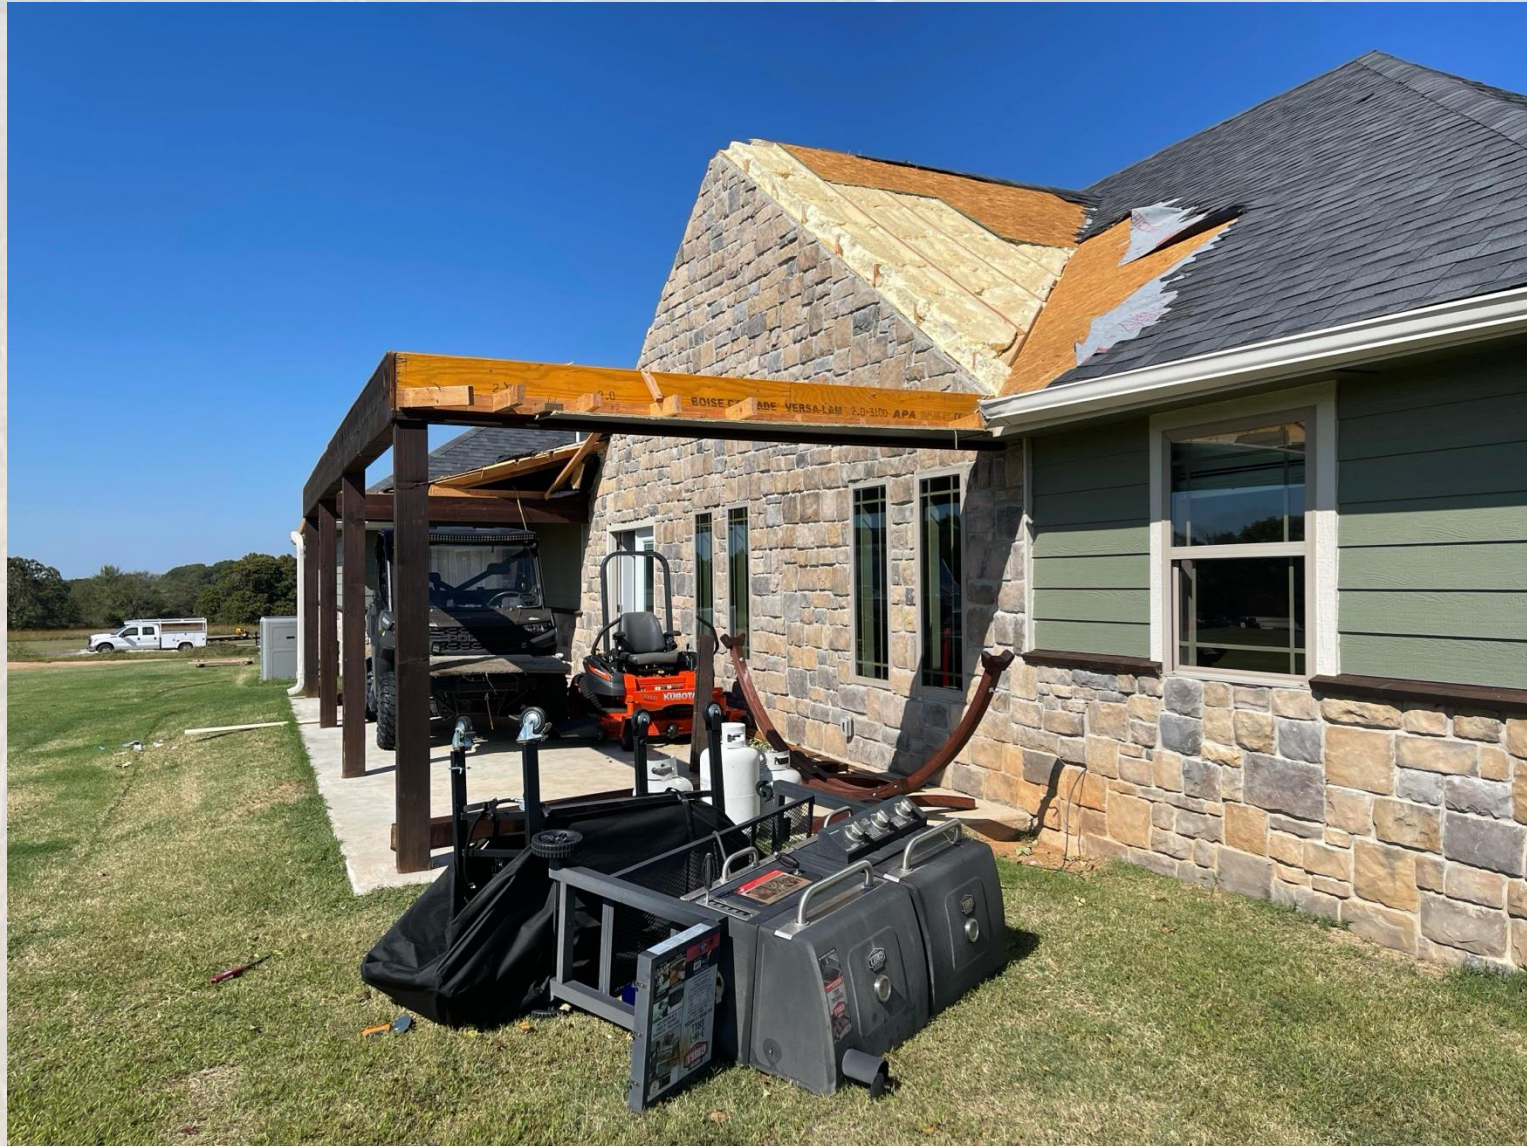
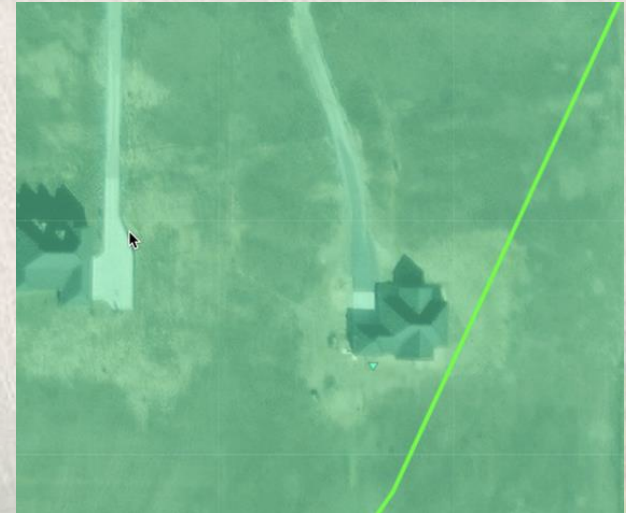
# Case 1: 10 Oct 2021 North of Ada, OK

- EF0 determined by the performance of the roof, degree of damage = 2, 80 mph wind
- Roof deck overhang connection was the weakness.
- Result: Roof deck peeled back, allowing water to damage the interior
- Smooth shank deck nails, no clips.
- Outsized damage for an EF0, even EF1

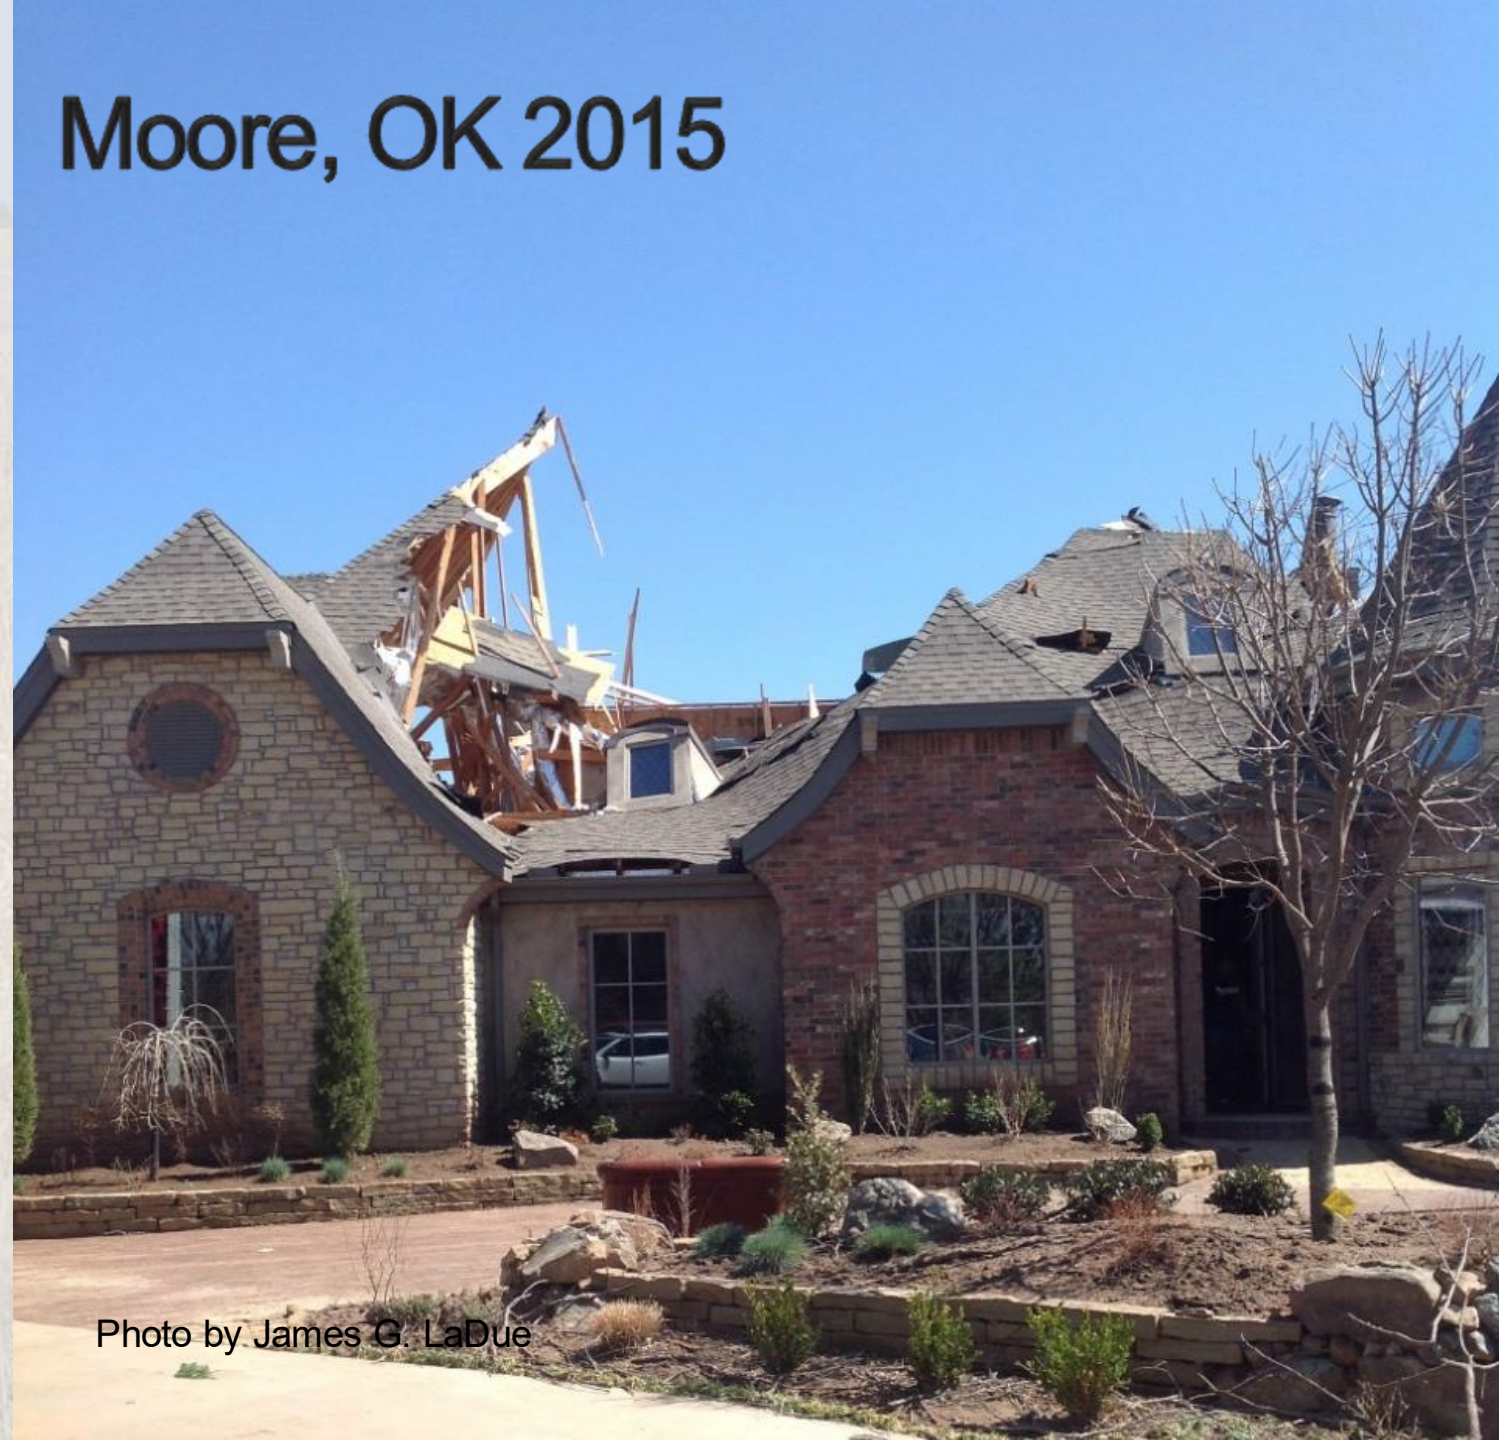
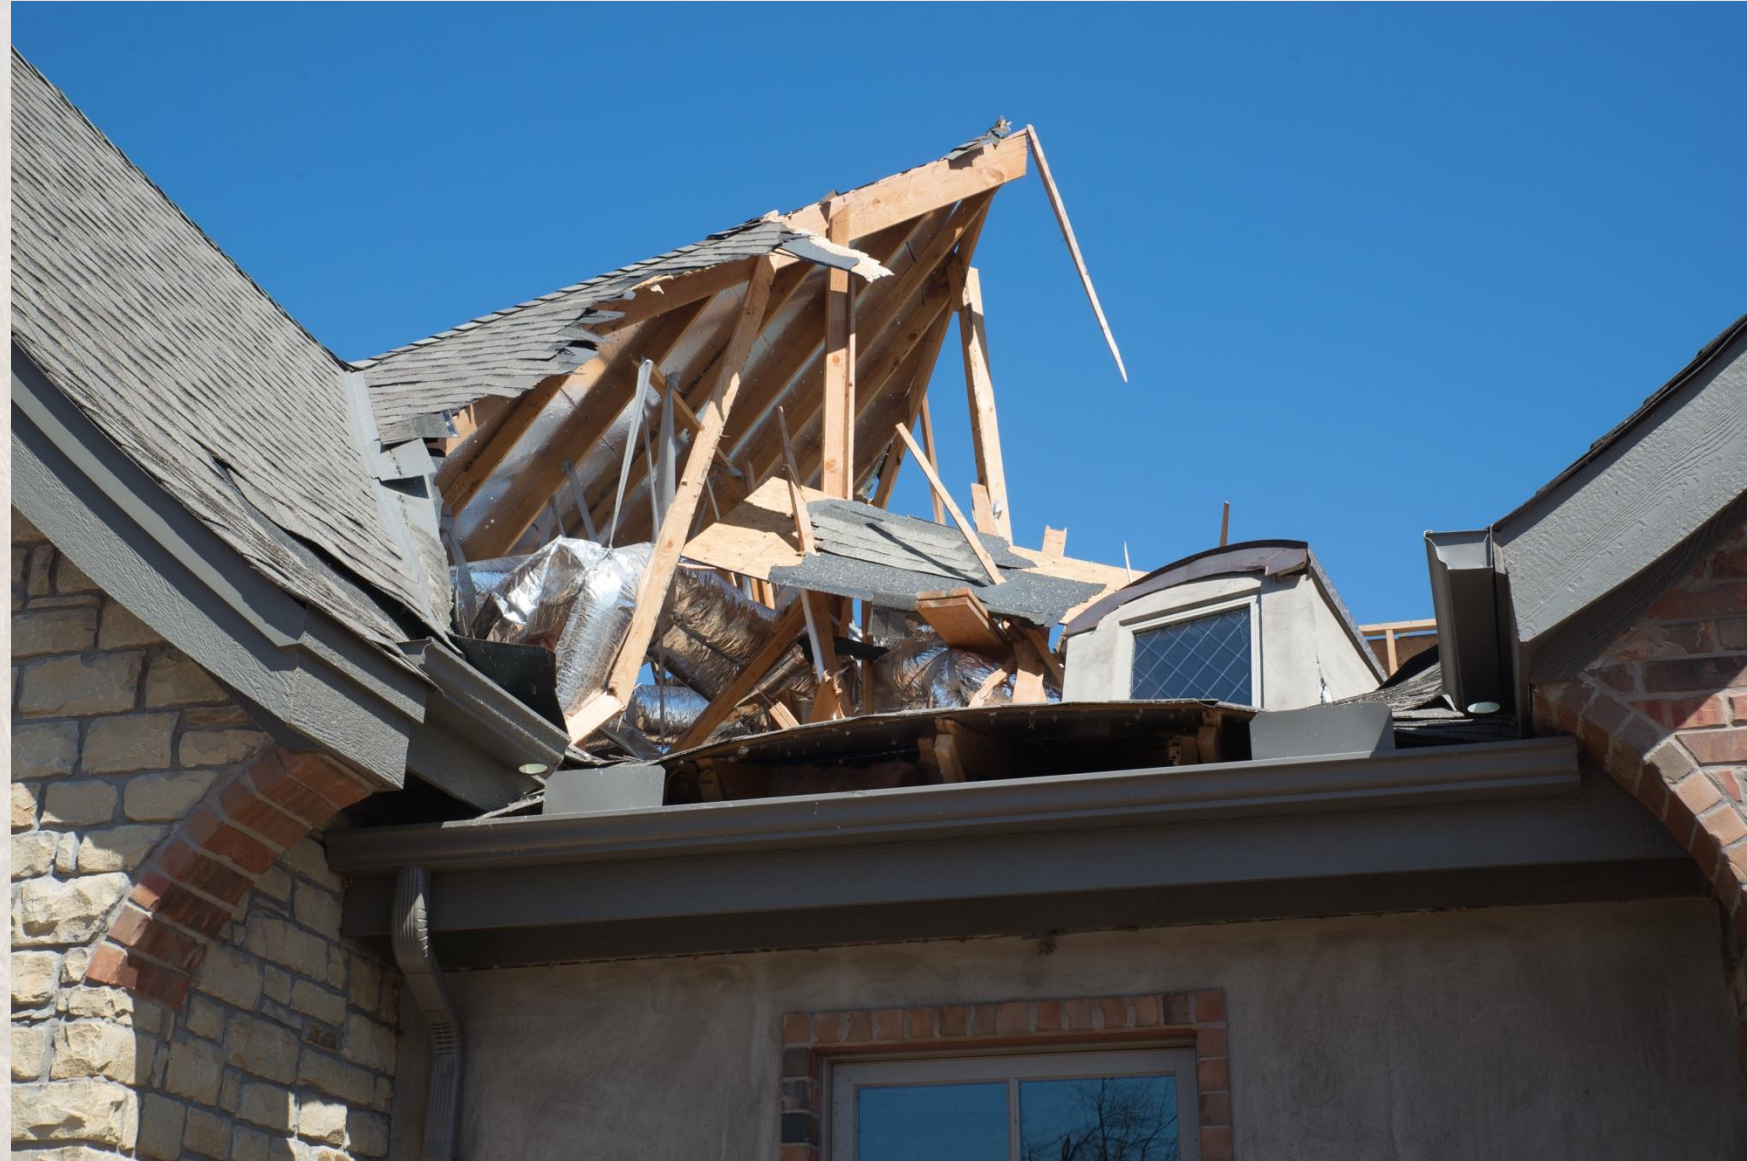
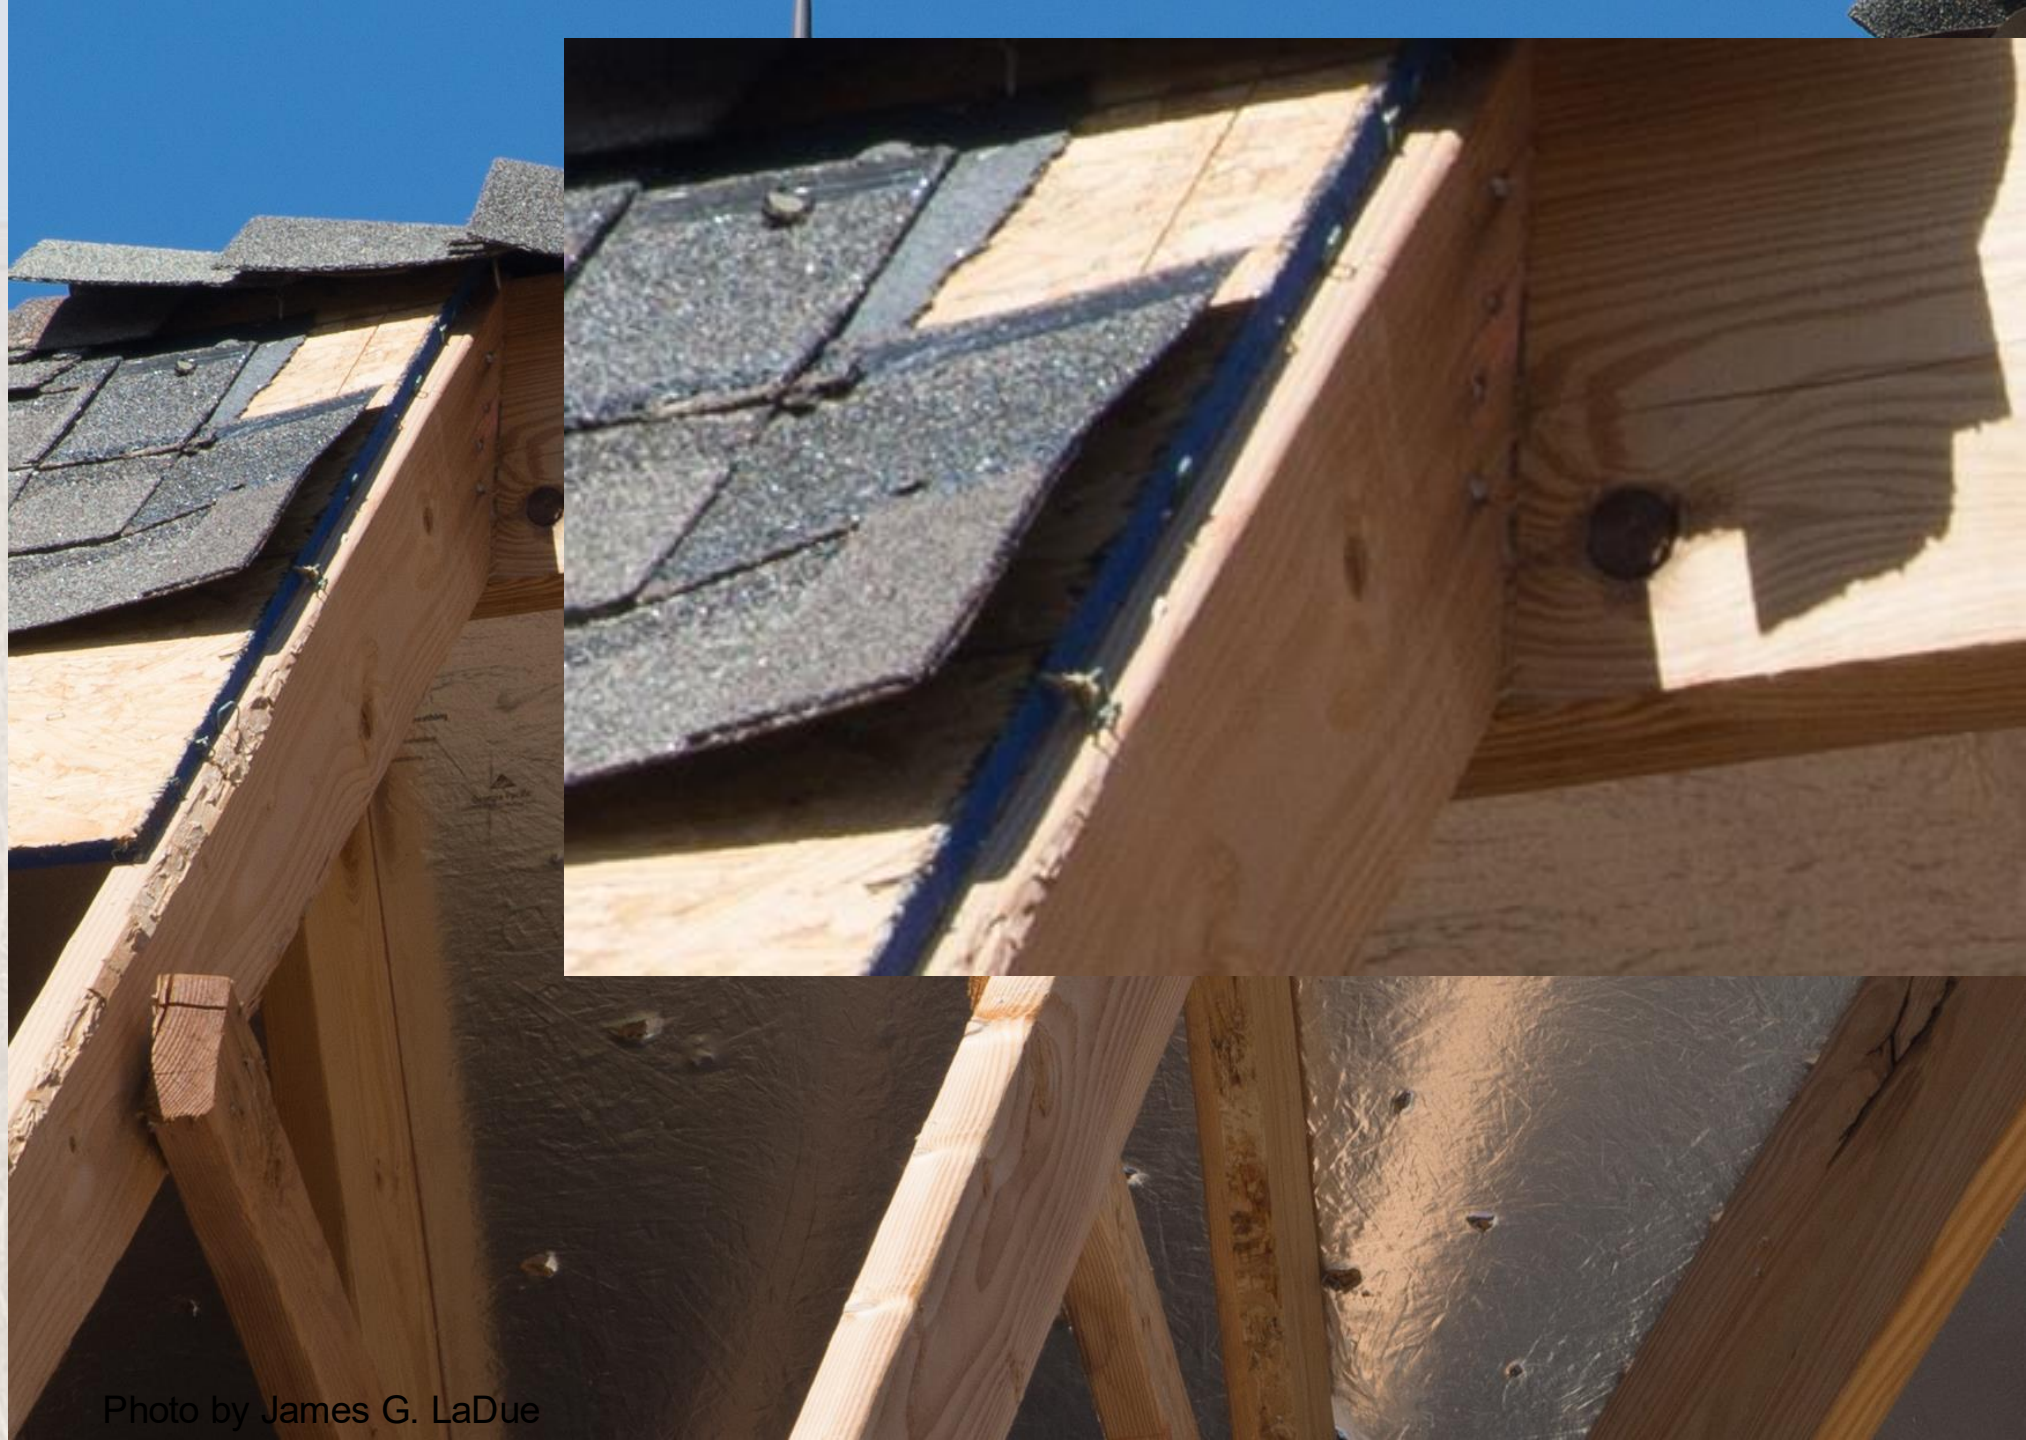
# Moore, OK 2015

- Degree of Damage 4: Uplift of roof deck > 20%
- Home followed Moore's new 130 mph code, except for...
- The stapled roof deck
- Guess where the damage occurred?
- 110 mph EF1 assigned in 2015
- Lower winds are likely

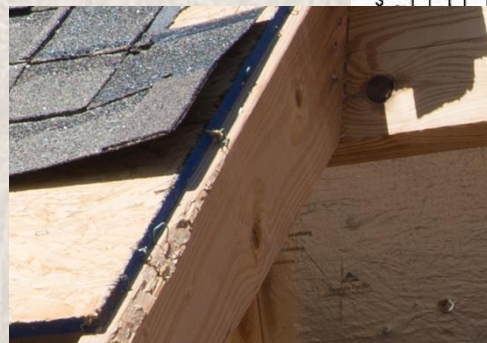
Fortified or similarly sealed  
roof deck

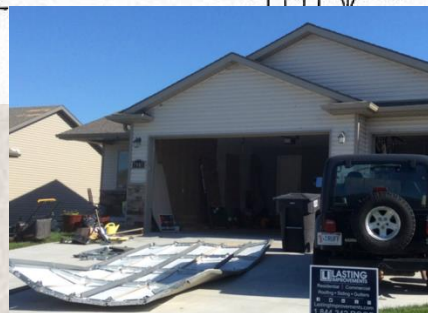
Stapled roof deck  
Missing deck nails

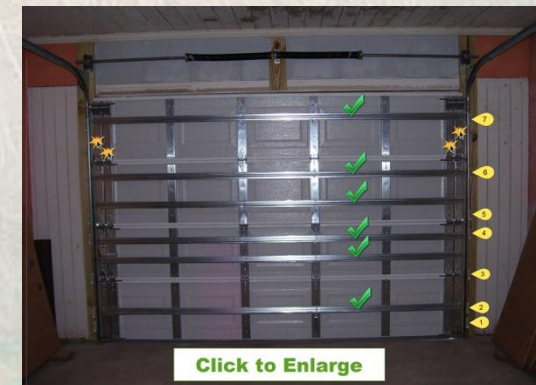
Standard garage  
doors <4 braces

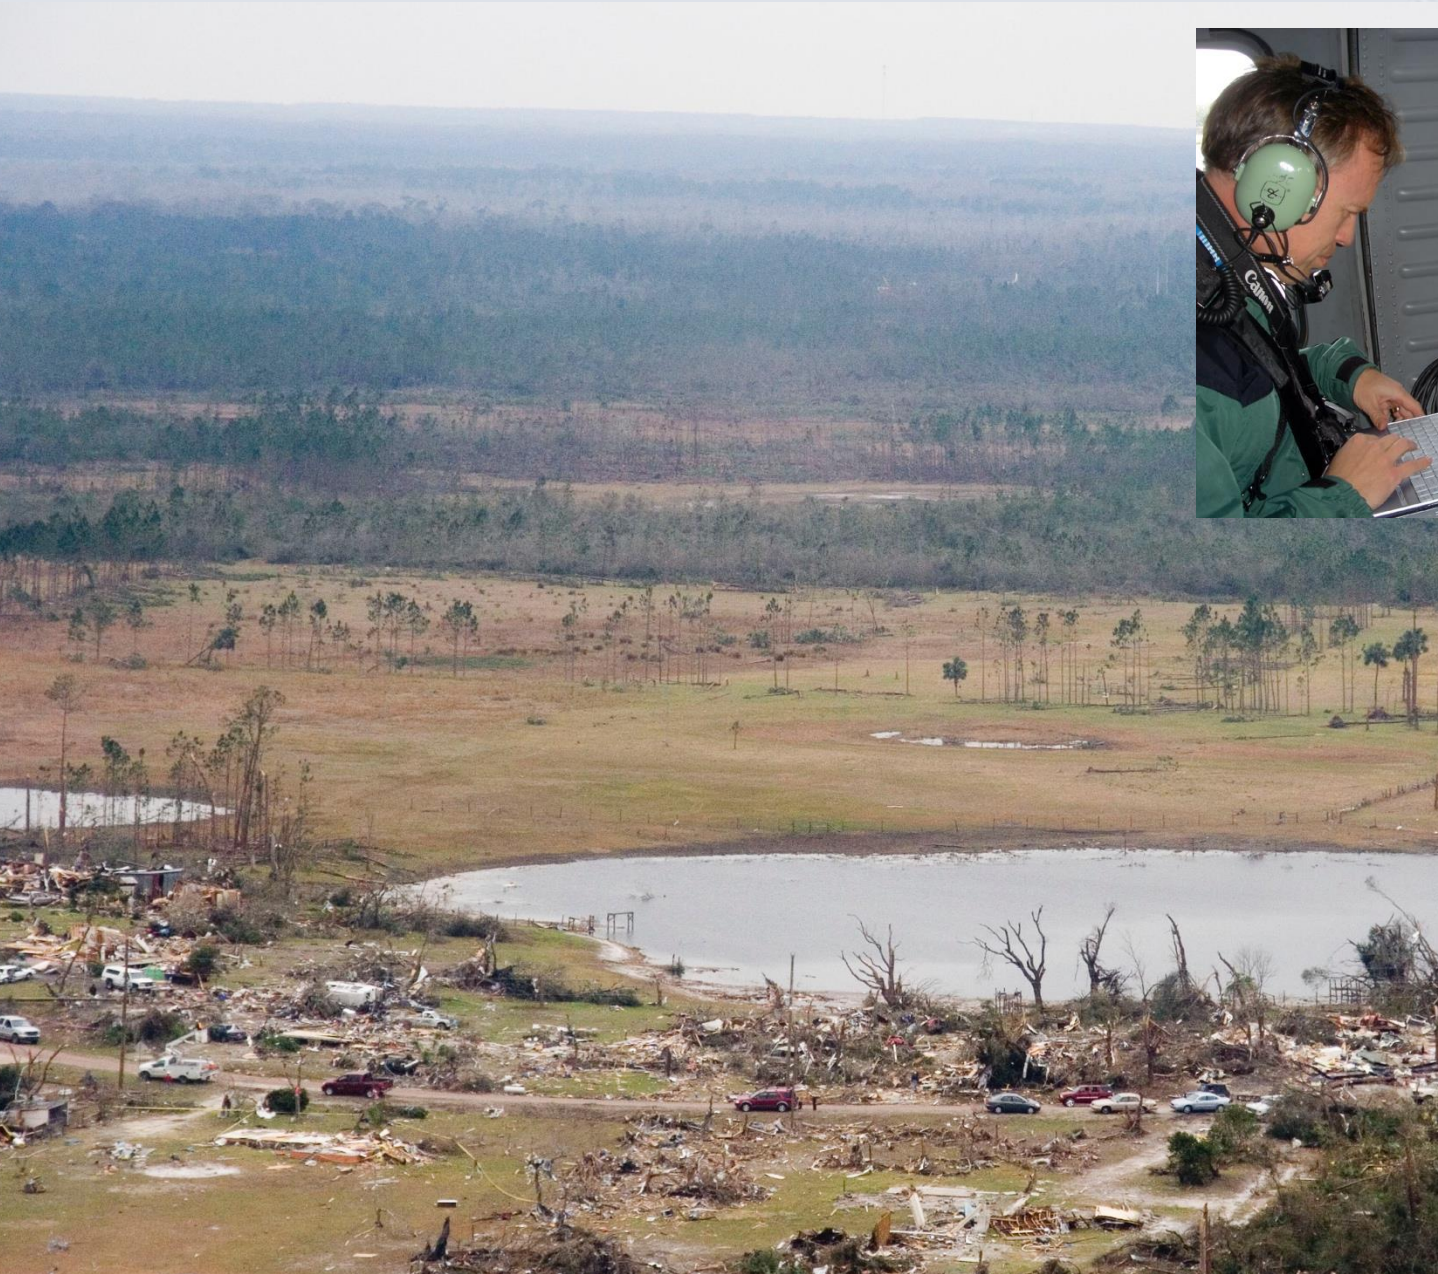
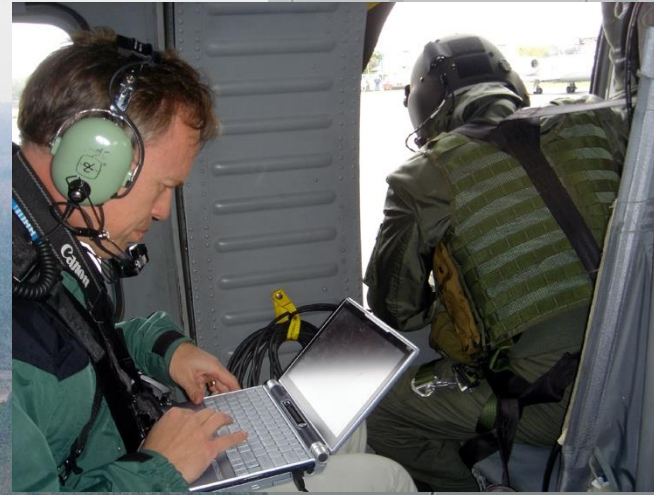
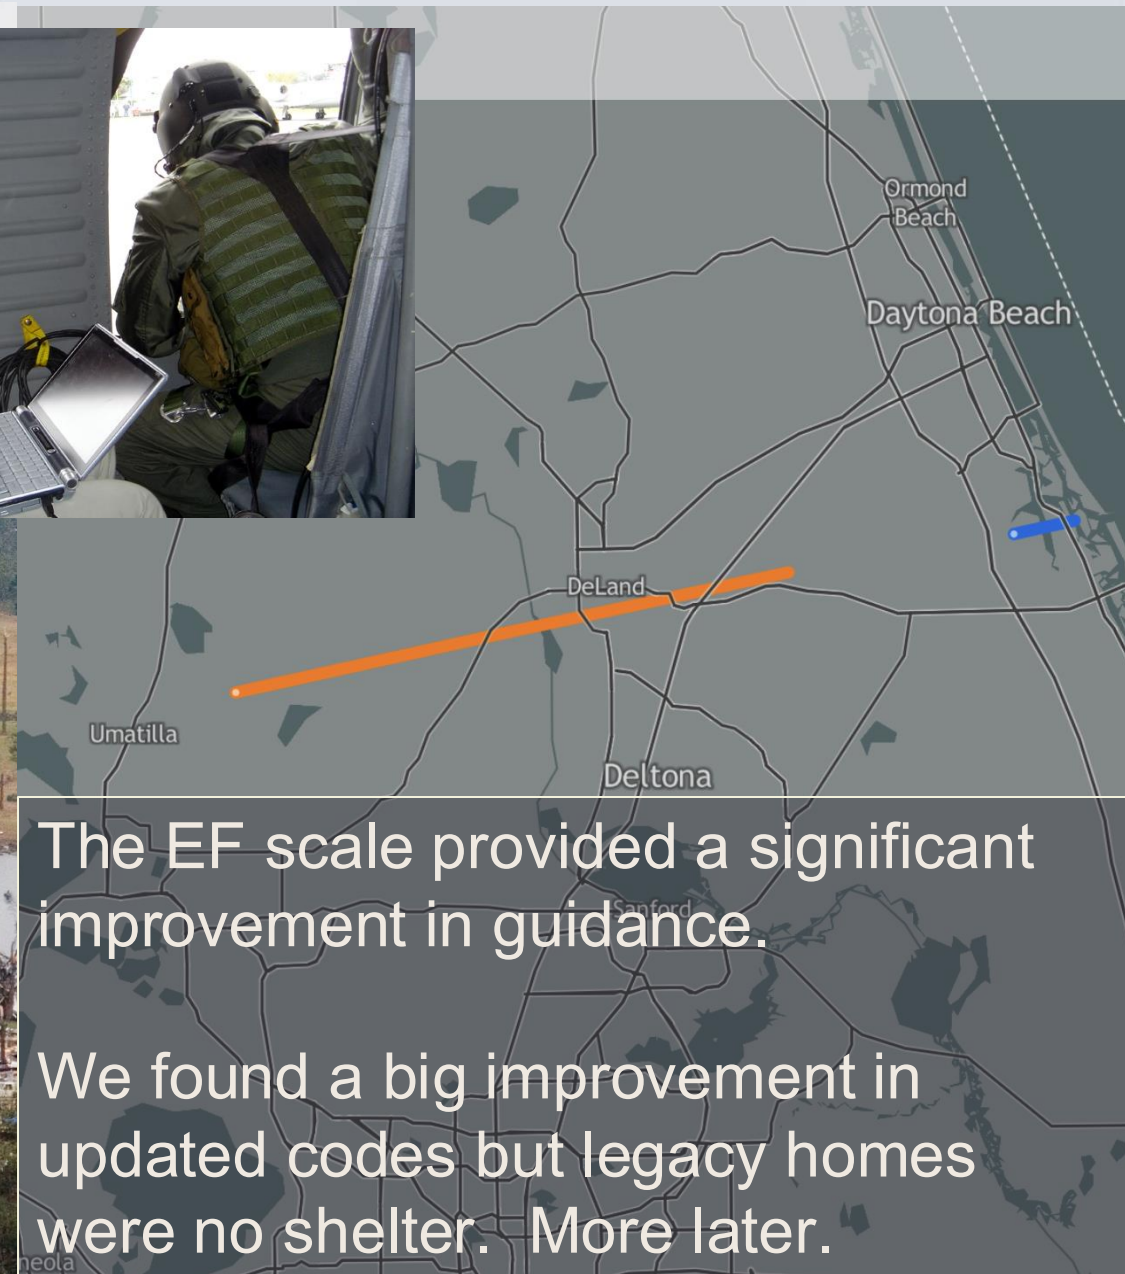
# 2007: Lady Lakes, FL, the 1<sup>st</sup> EF-rated Tornado Day

We found a big improvement in updated codes but legacy homes were no shelter. More later.

The enterprise school failed the students due to lack of continuous load paths.

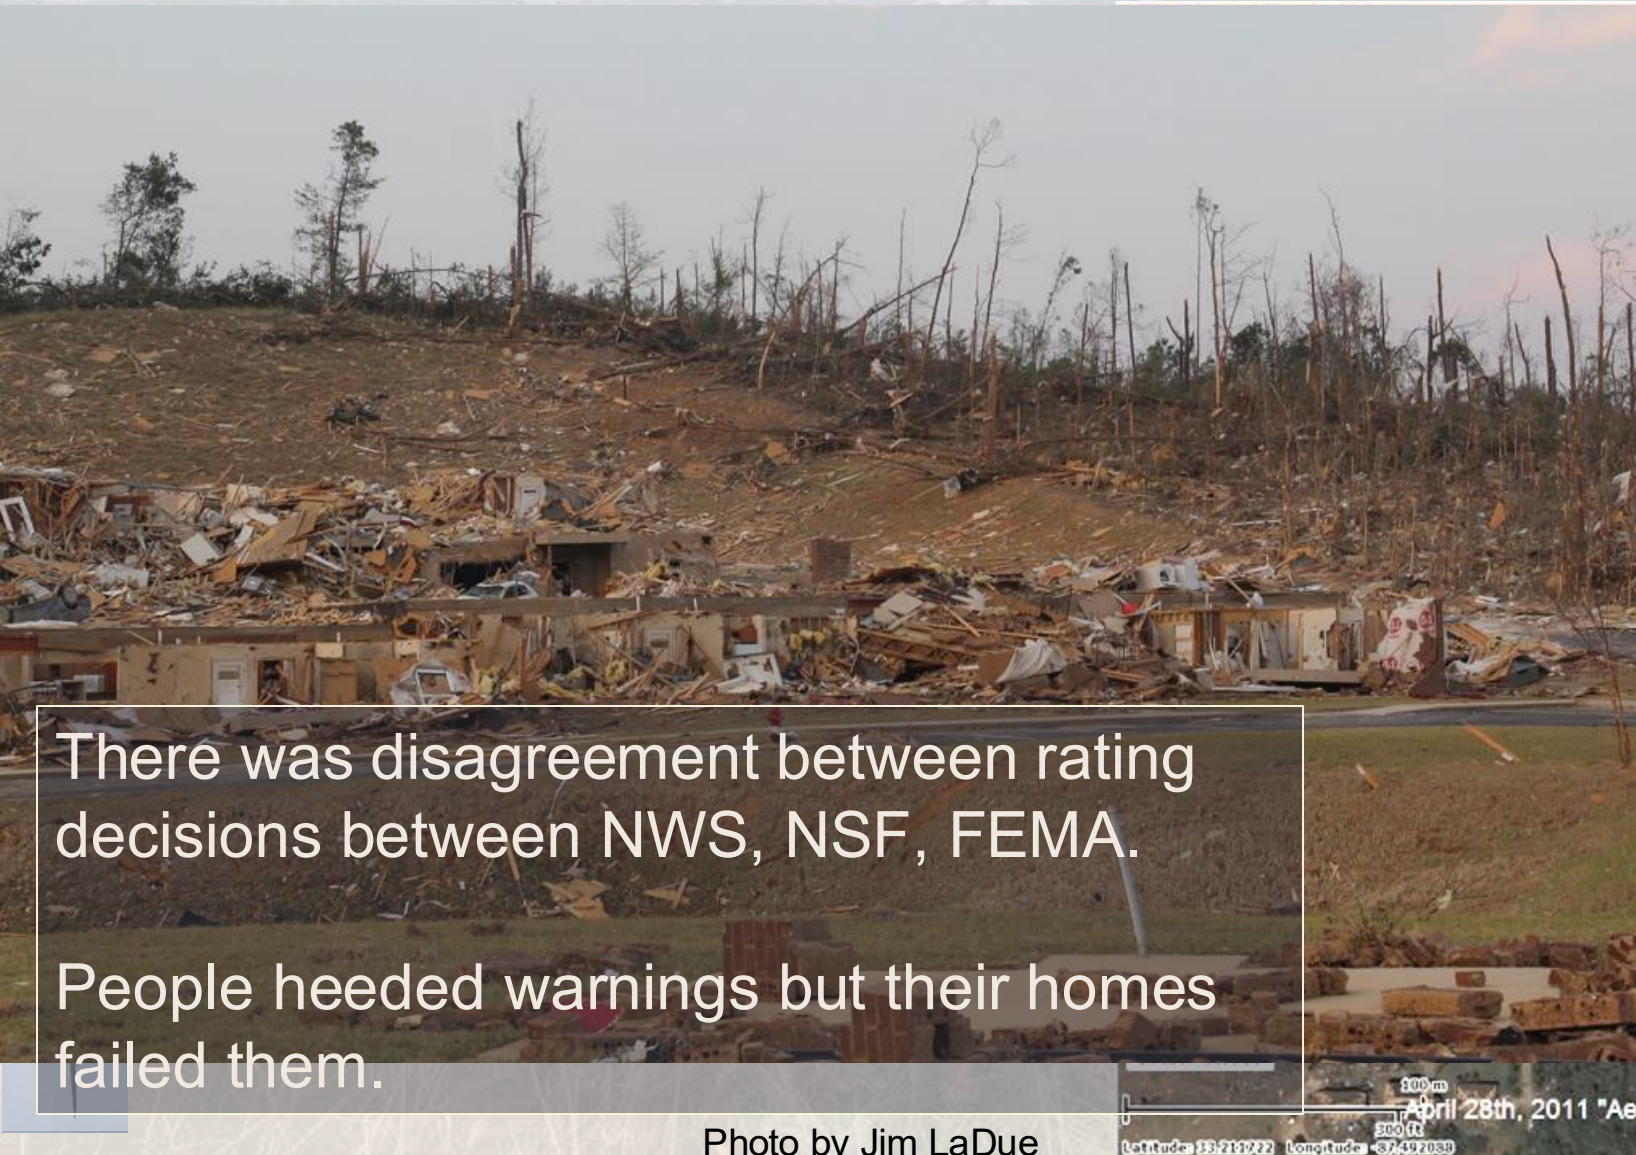
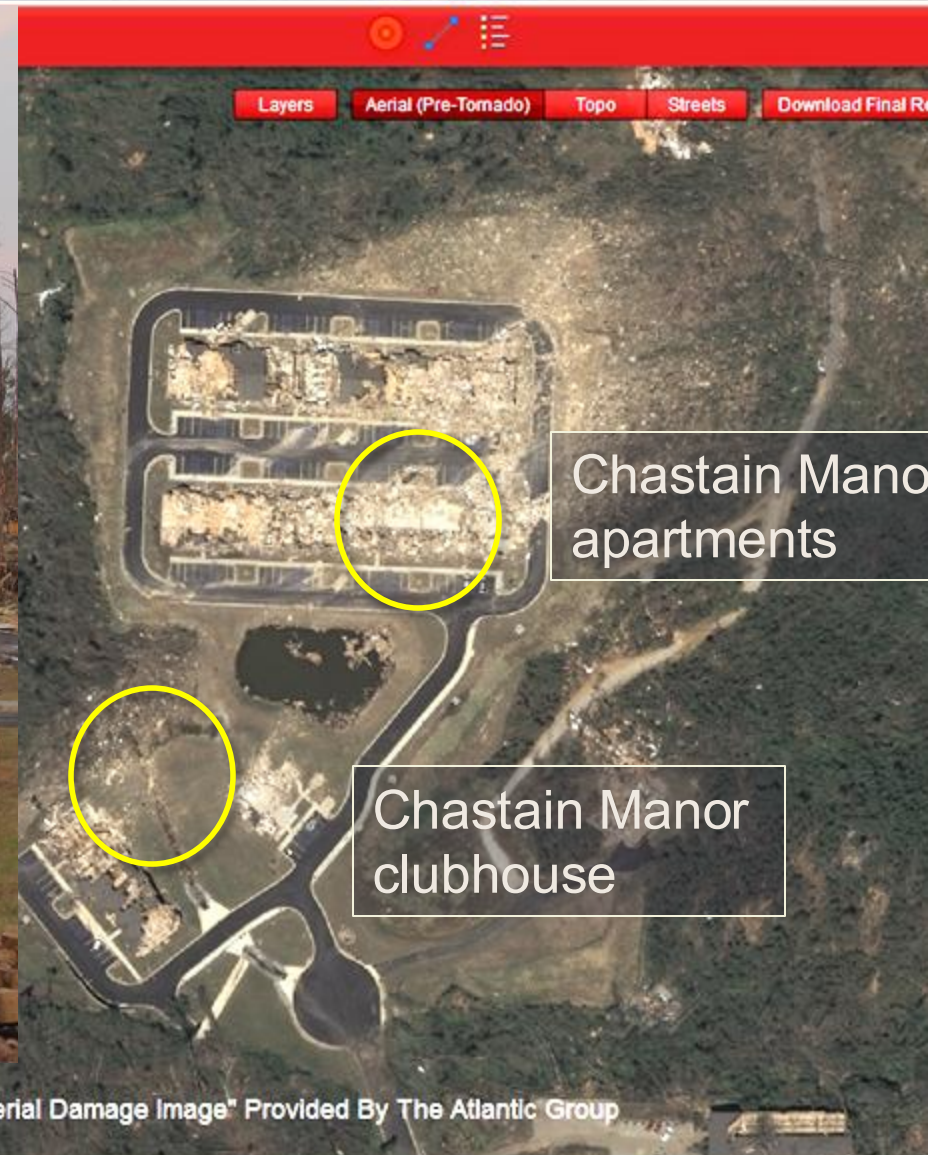
# 2011: Super Outbreak,

There was disagreement between rating decisions between NWS, NSF, FEMA.

People heeded warnings but their homes failed them.

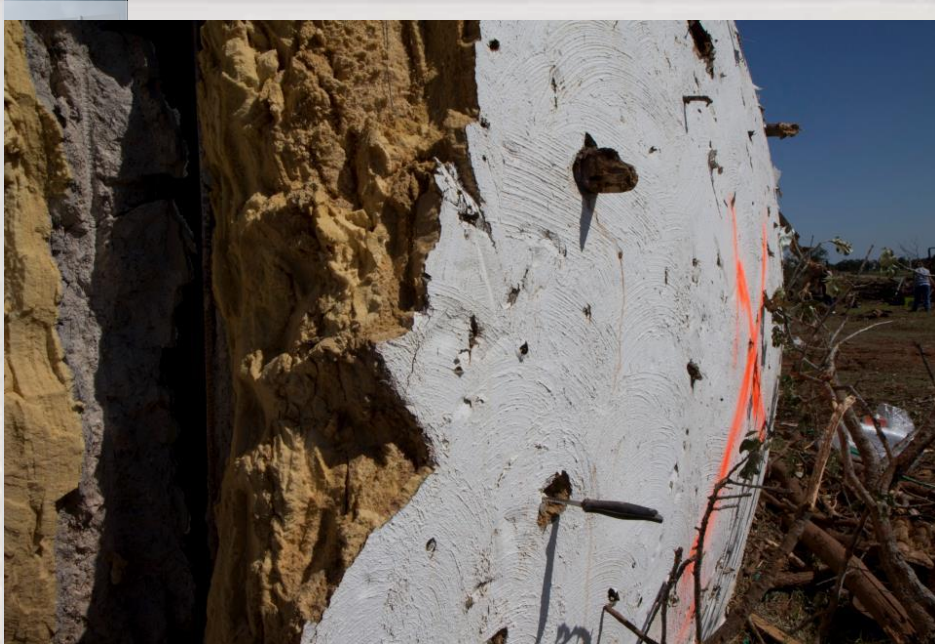
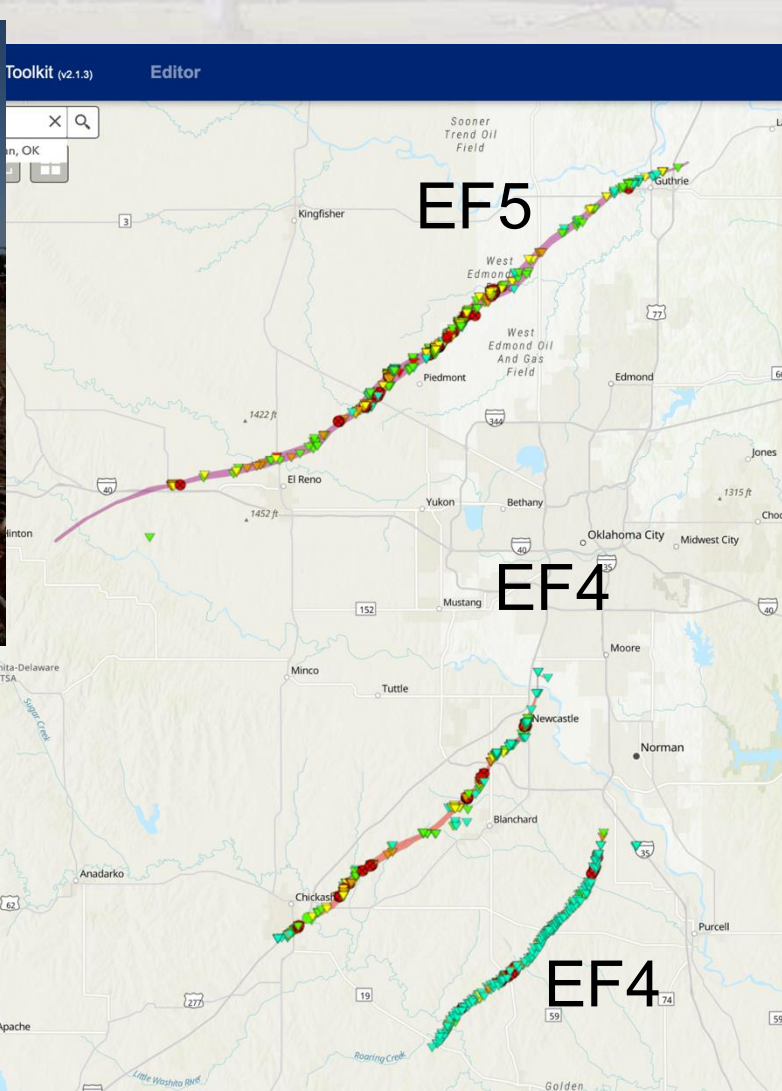
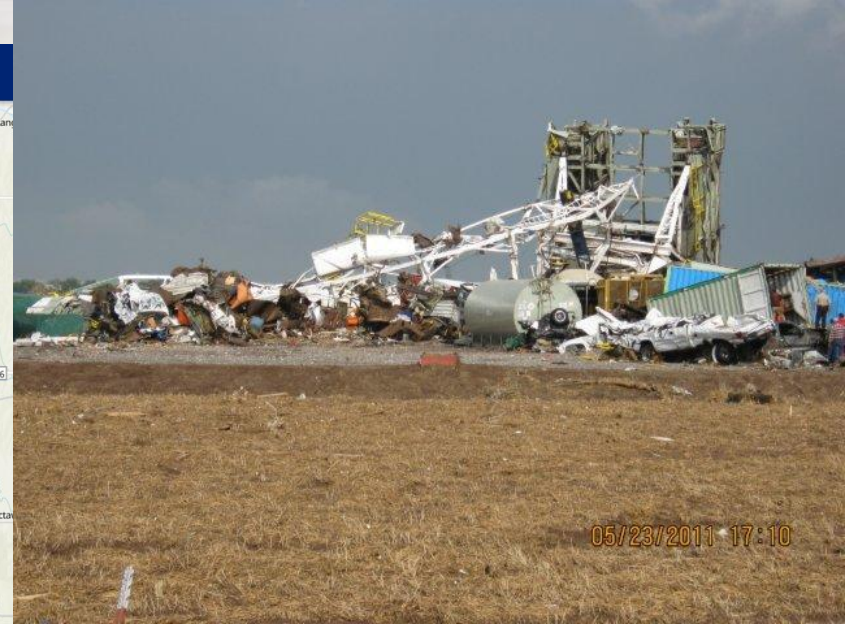
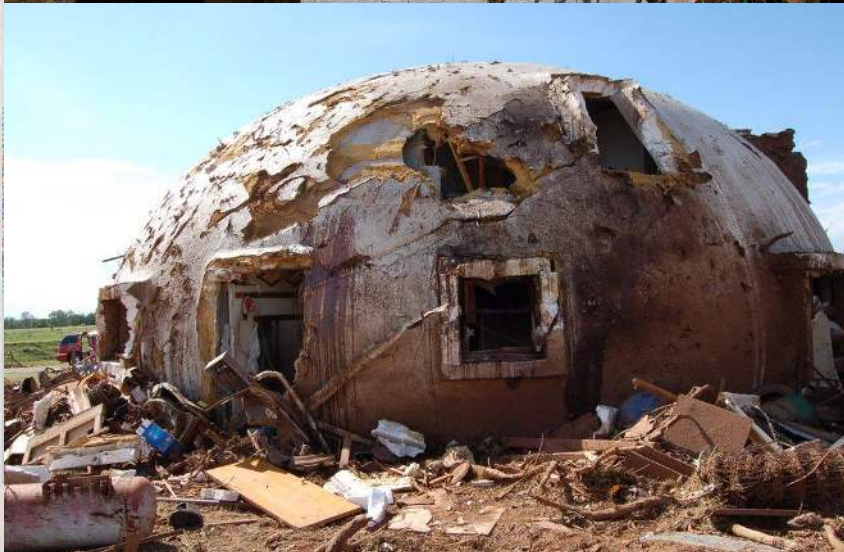
# 2011 May 24: OK Tornado Outbreak:

This only EF5 was based on radar and the drilling rig.

A reinforced concrete dome house provided shelter had the residents walked into the bathroom.
